Diagnosing and Solving Corrosion Problems in Jordanian Industry (Case Study)

Farqad Al-Hadeethi

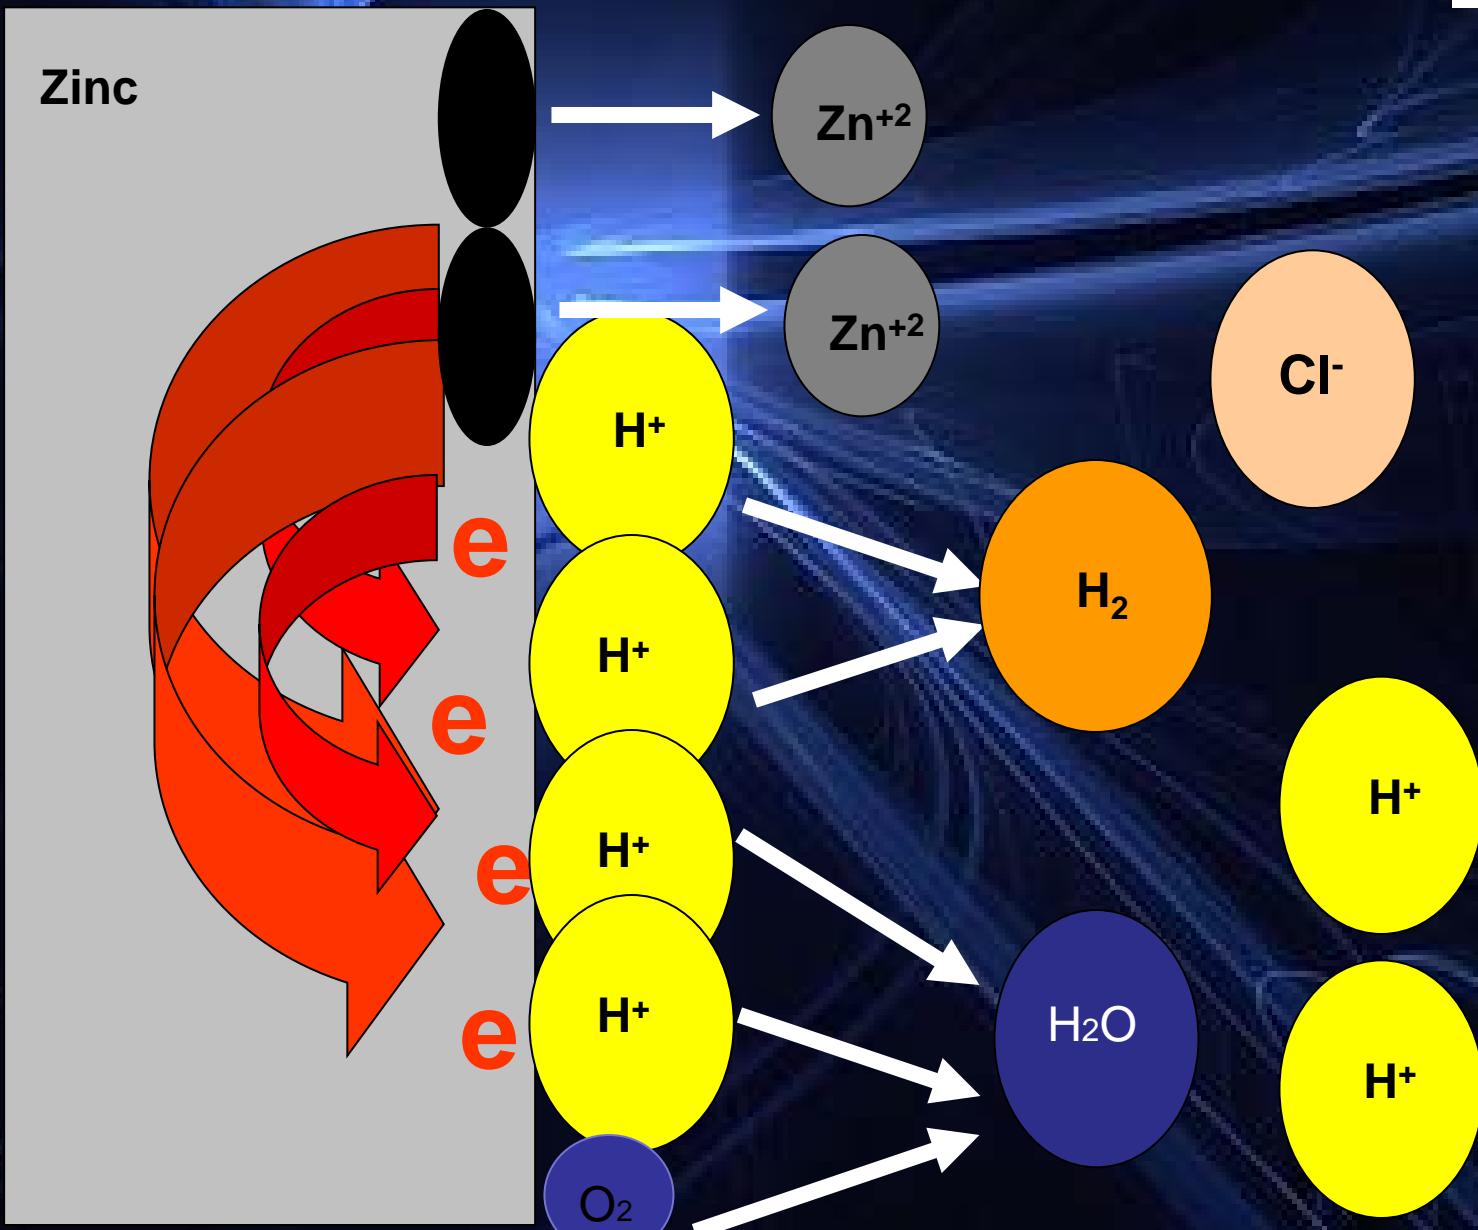
- Loosing Mechanical Properties
- Direct Economical Losses: results from replacing corroded structures
- Indirect Economical Losses: shutdown, loss of product, loss of efficiency, over design
- Appearance
- Contamination of Products
- Loss of Safety

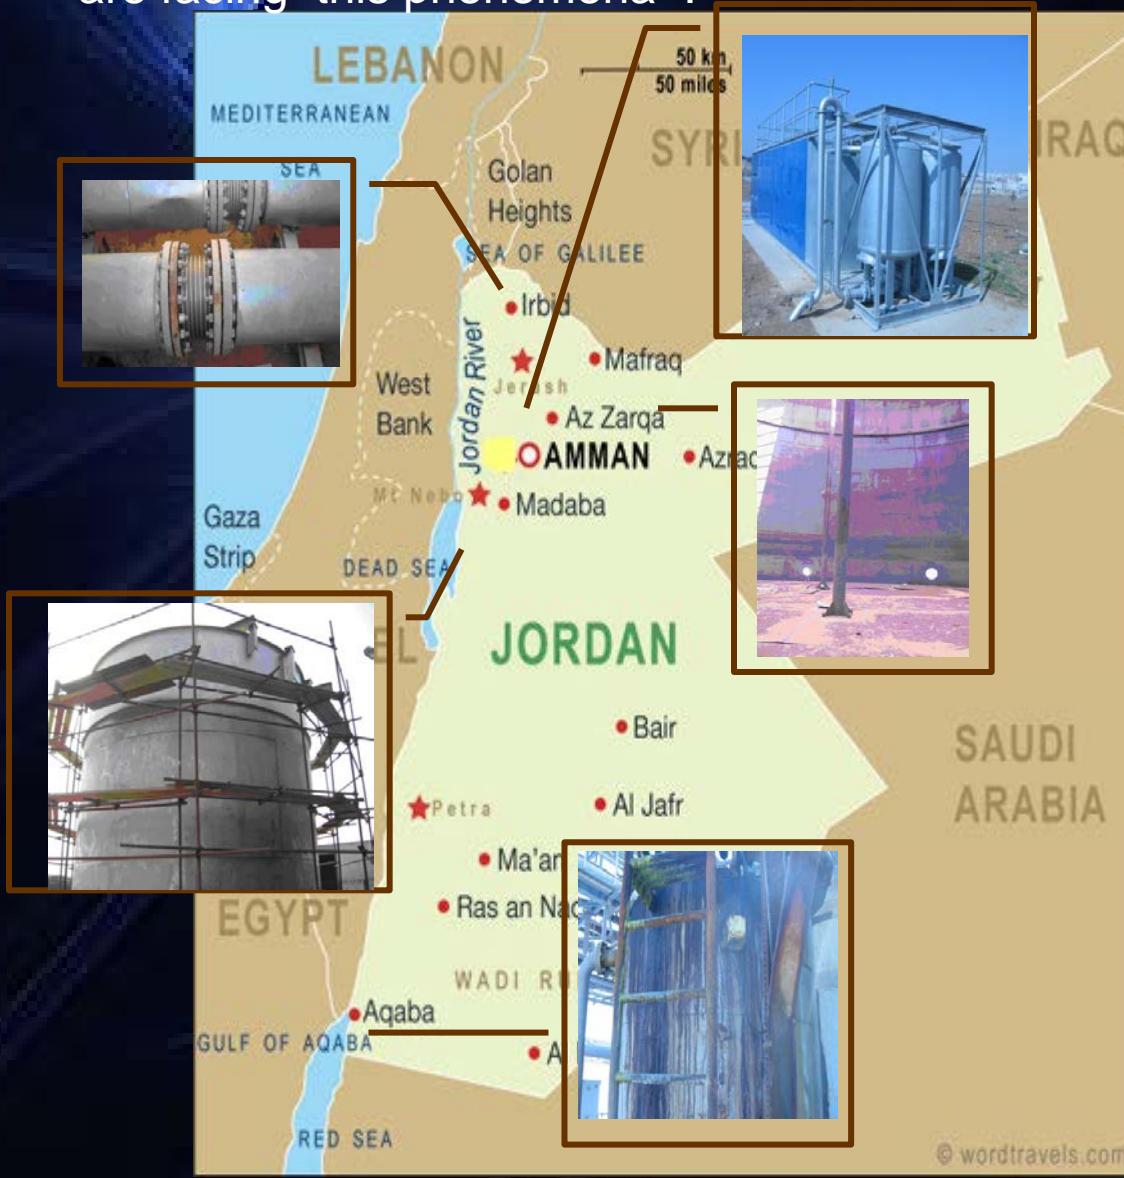
After accomplishing more than 60 consultancy studies to solve corrosion problems, It is obvious that many industries in Jordan are facing this phenomena :

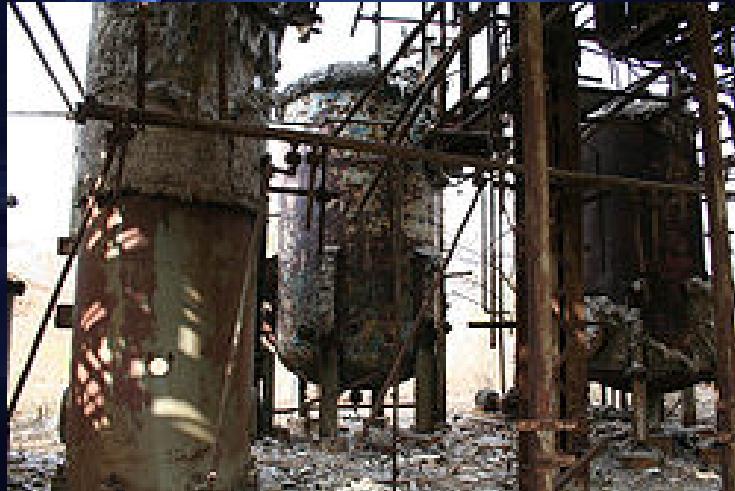
INDIA , 1984 ,
17000 Died,
558,125 permanent
Injuries

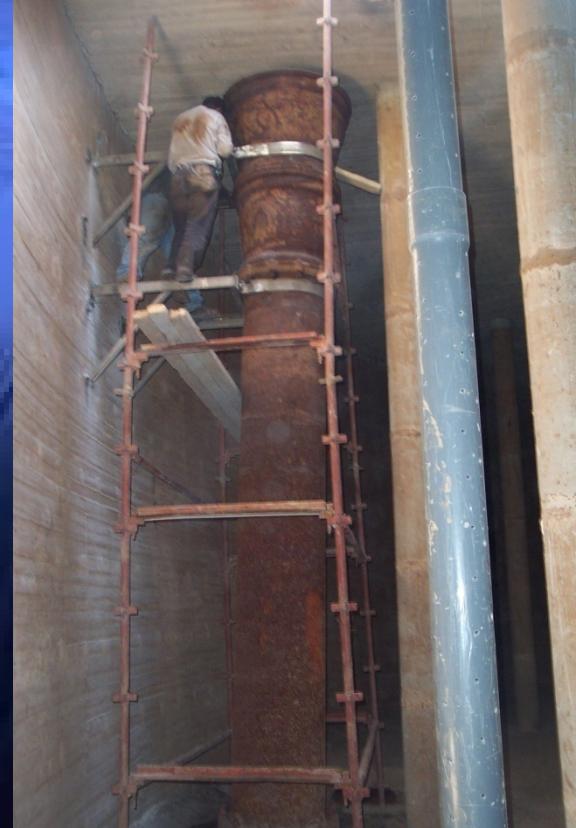
Uniform attack occurs with equivalent intensity over the entire exposed surface.

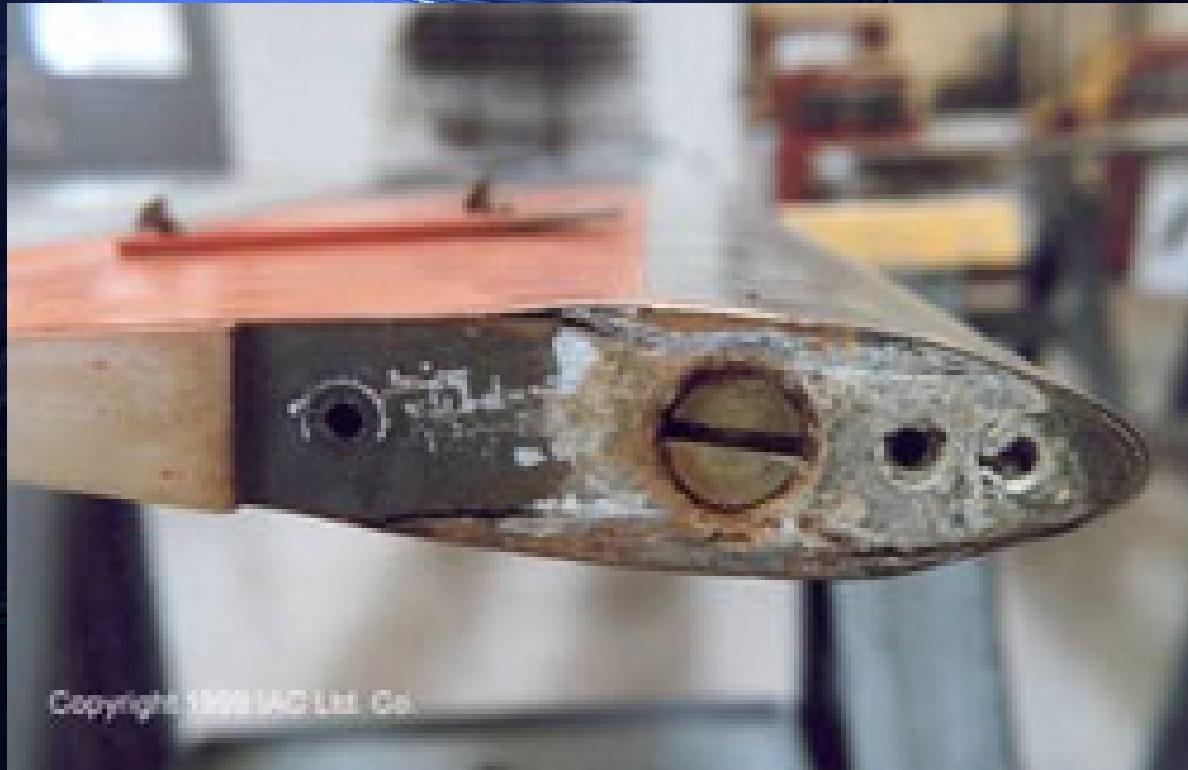
Aluminum helicopter blade has corroded because of galvanic or bimetallic action where it was in contact with a steel counterbalance

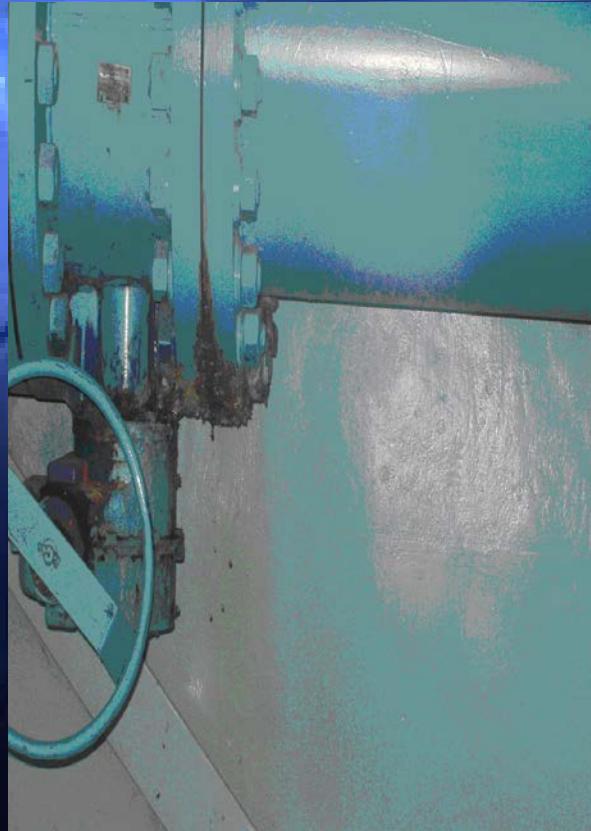
Occurs as a consequence of concentration differences of ions in the electrolyte solution.

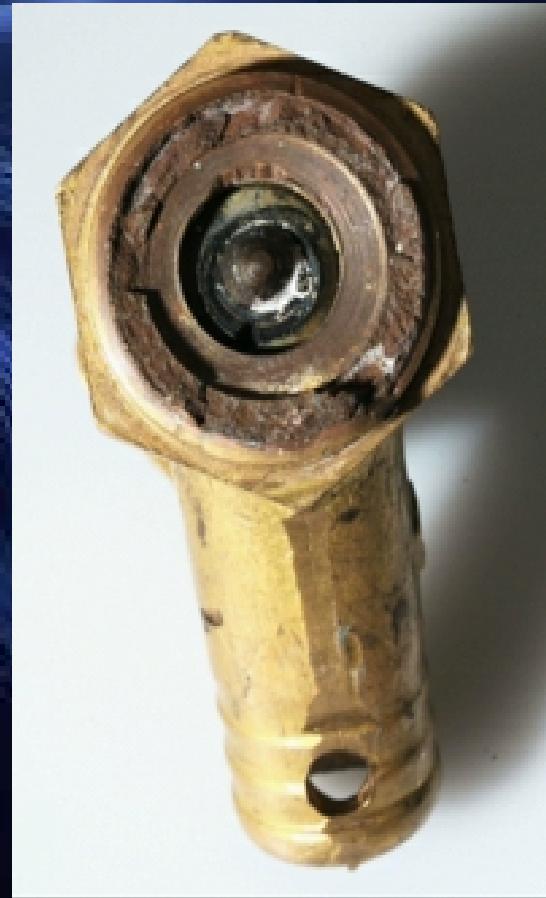
Many brass plumbing fittings have electrochemical cells between their constituent phases. This leads to rapid corrosion cracks which have a coppery color due to dezincification where the zinc content is leached out.

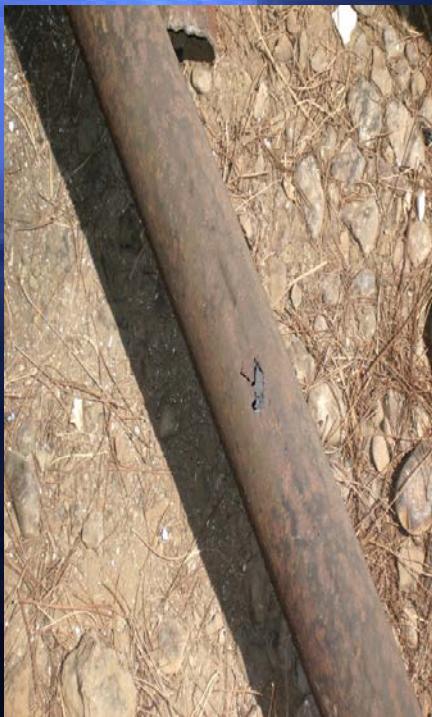
It is a form of localized corrosion attack in which small pits or holes form. They penetrate from the top of a horizontal surface downward in a nearly vertical direction.

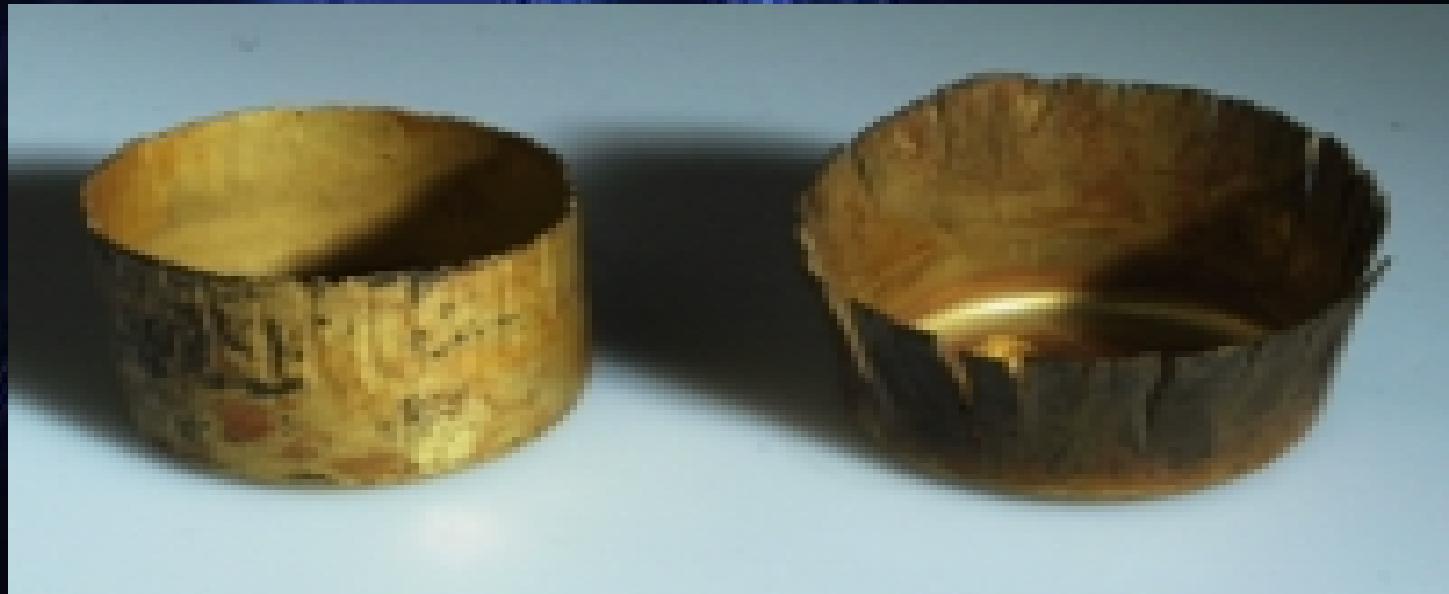
The deep drawn brass cup on the right shows stress corrosion cracking under the influence of the residual manufacturing stresses and a mildly corrosive environment. The cup on the left has been annealed before putting it into service which solves the problem.

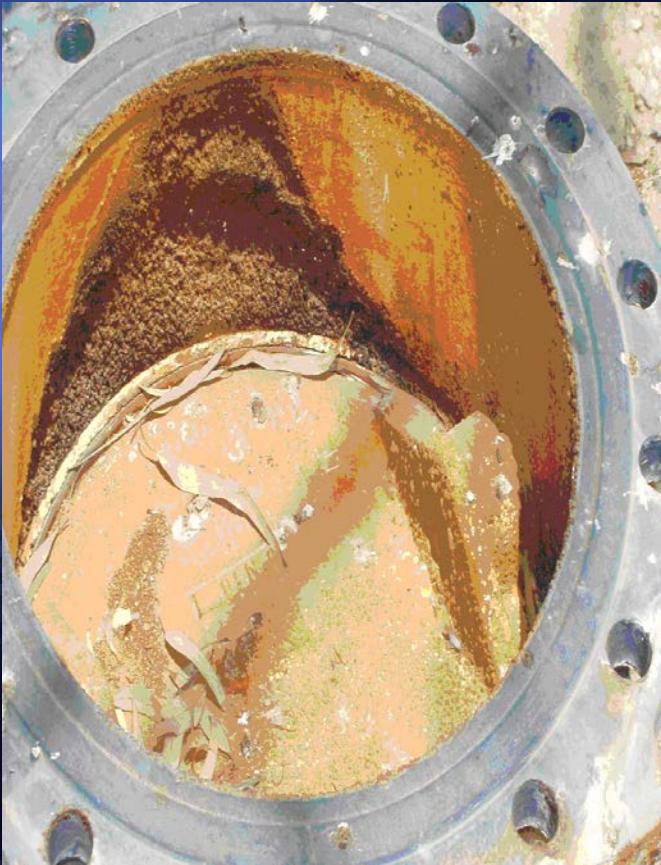
Arises from combined action of chemical attack and mechanical abrasion or wear as a consequence of fluid motion.

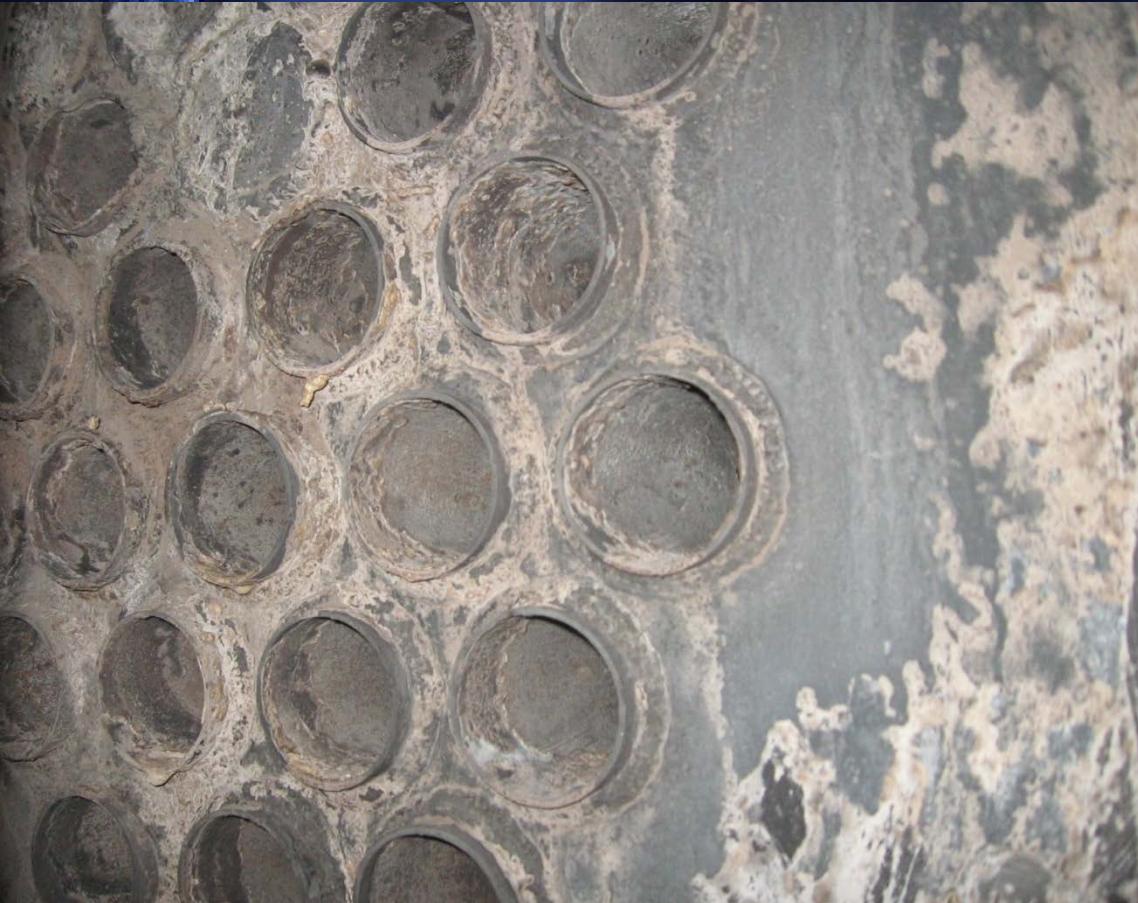
Fig.(1) : Fire tubes of the boilers

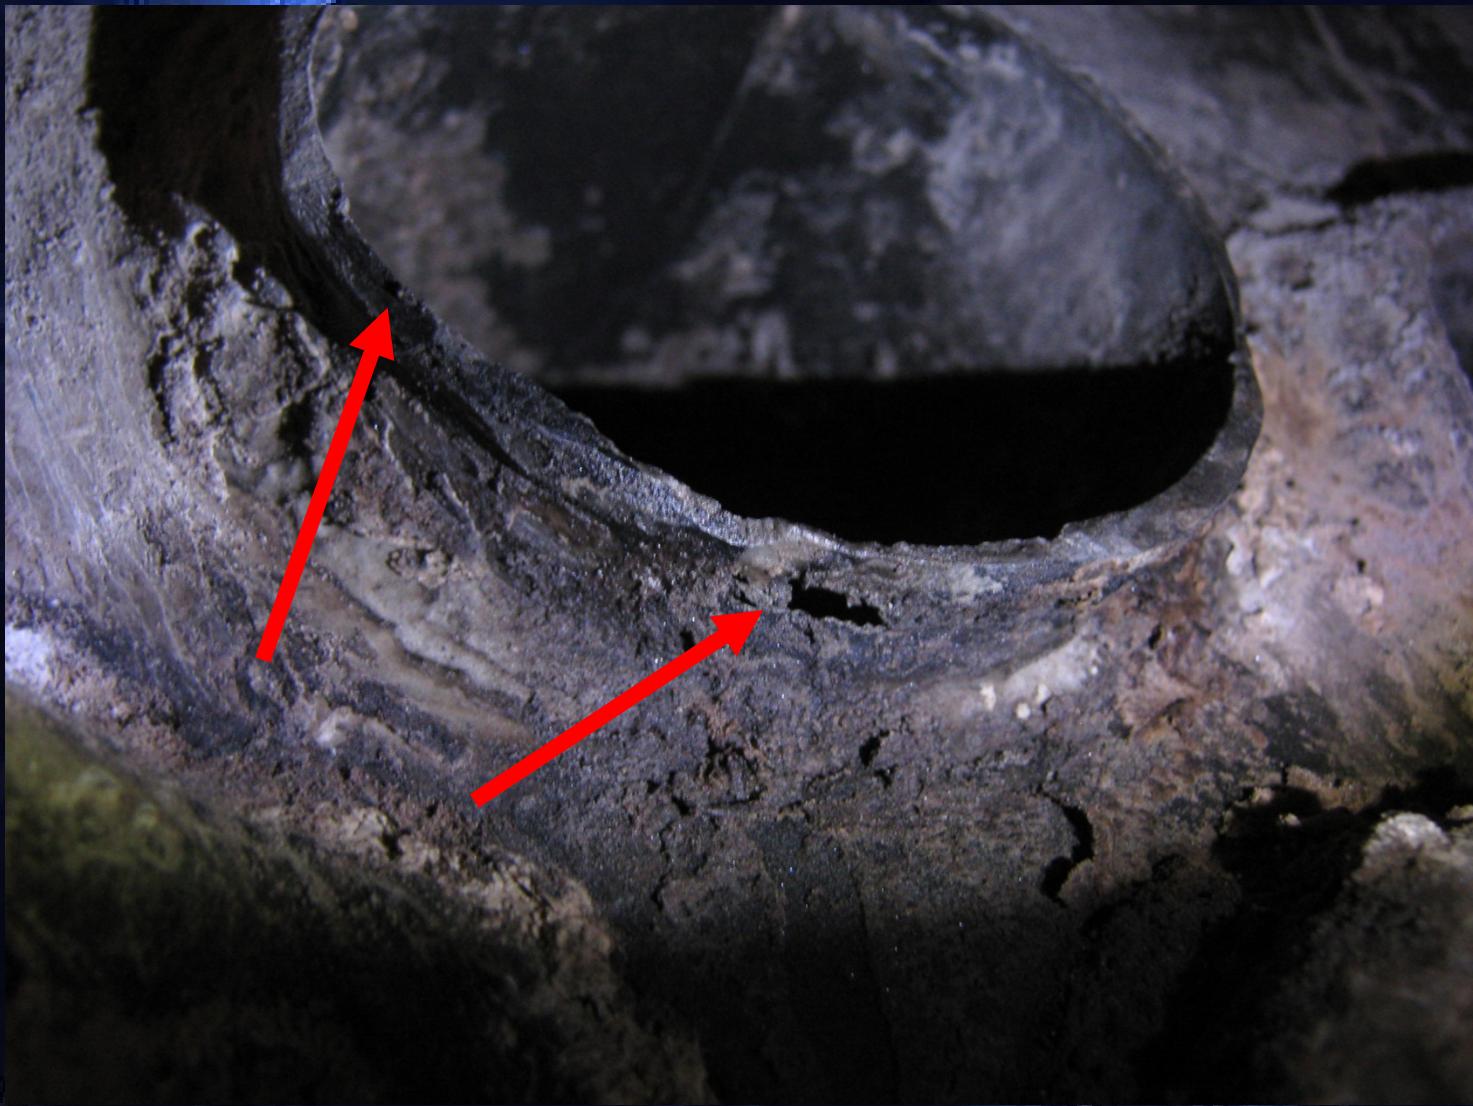
Fig.(2) : Corroded fire tube with full deterioration in the material as shown in the red arrows

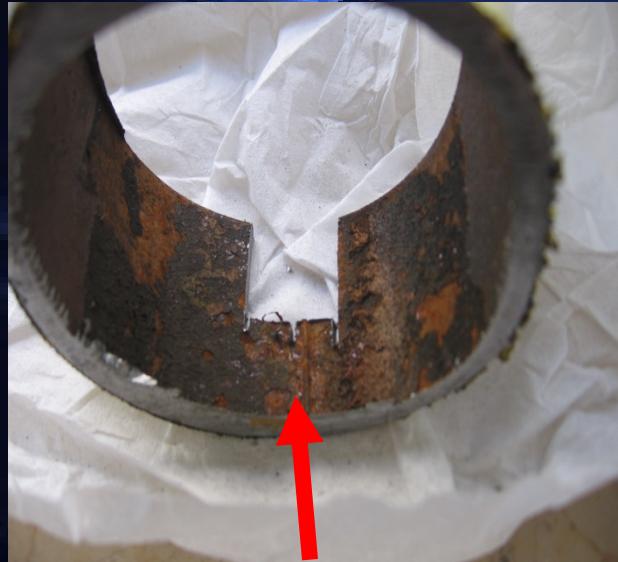
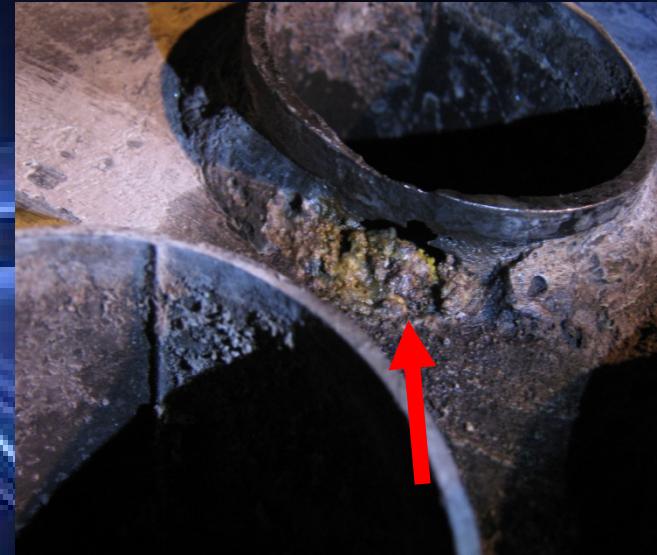
**Fig.(3) : (a) Part of the failed fire tube showing the corrosion products on the internal surface as shown in the red arrow
(b) Corrosion products near the opening of the fire tube external surface located at the rear side of one of the boilers.**

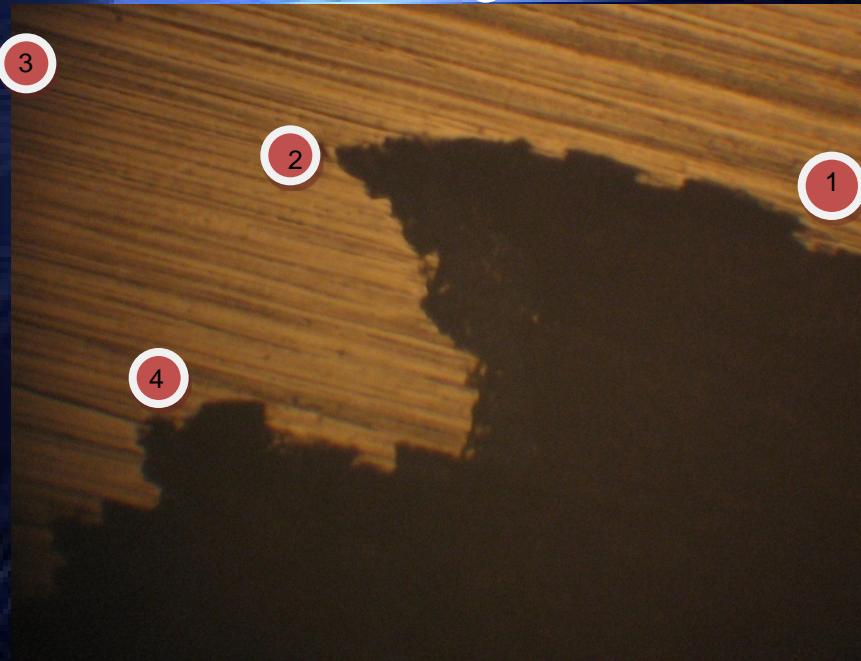
Fig.(5) : Part of the failed fire tube surface magnified using optical microscope (200 X) showing the random selected spots to measure the microhardness near a shallow and deep pit.

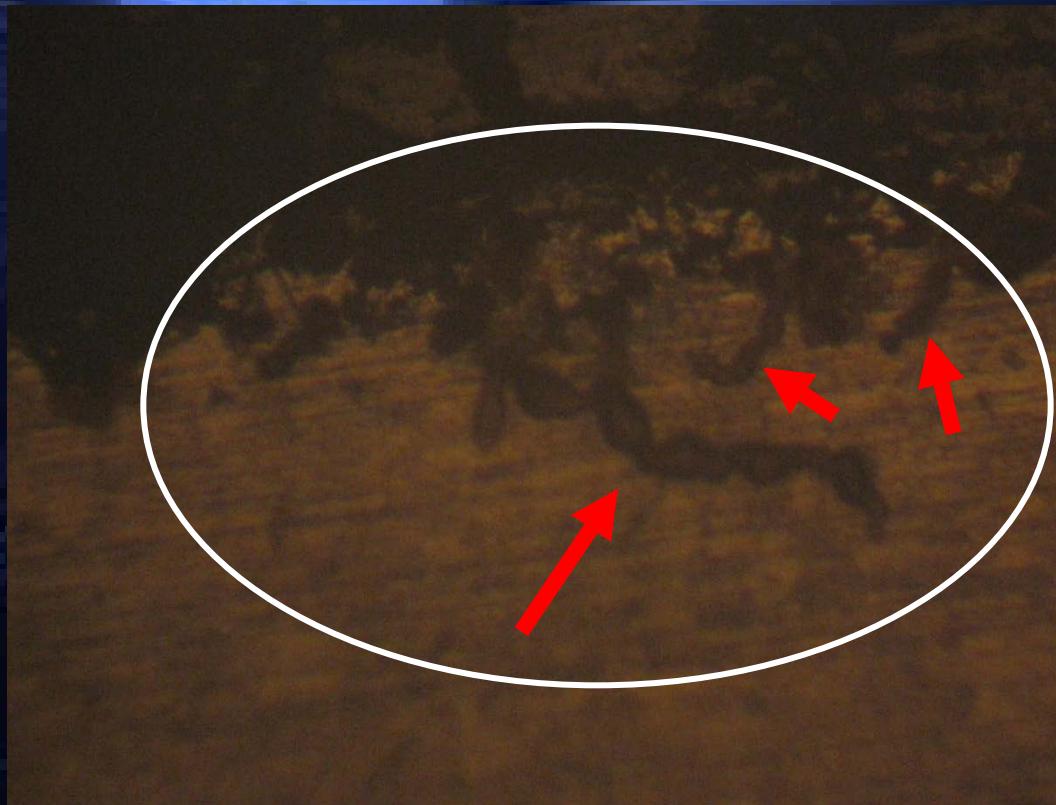
Fig.(6) : Clear pits propagated into large " WORM HOLES" as shown in the red arrows

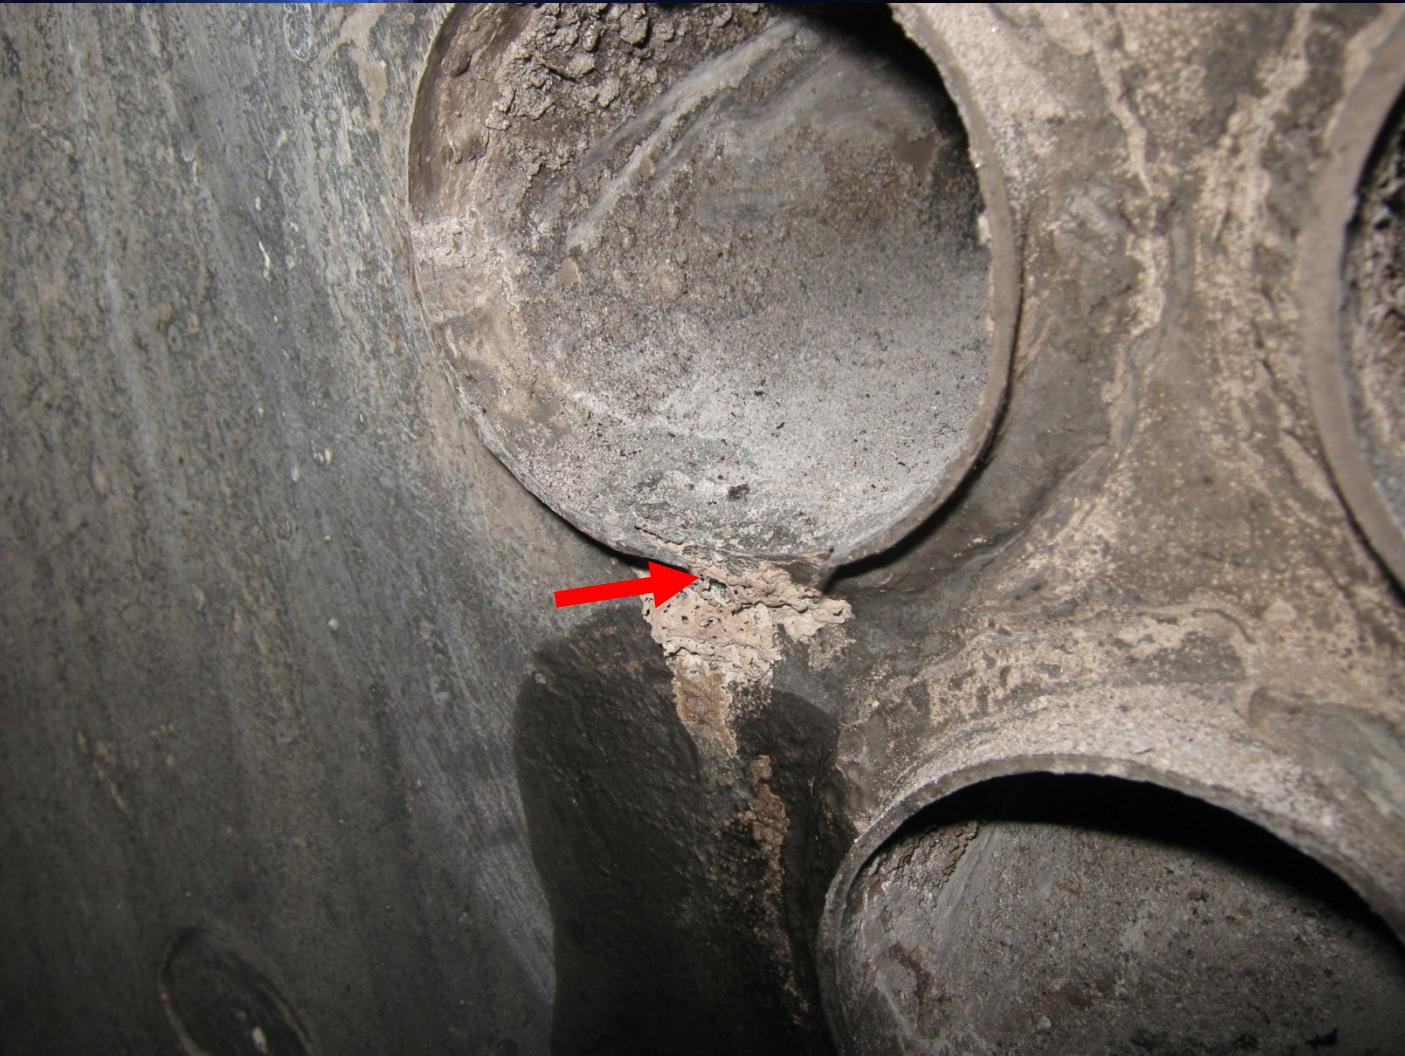
Fig.(10) : Reduction in thickness in the lower part of the fire tube with complete deterioration in the material as shown in the red arrow.

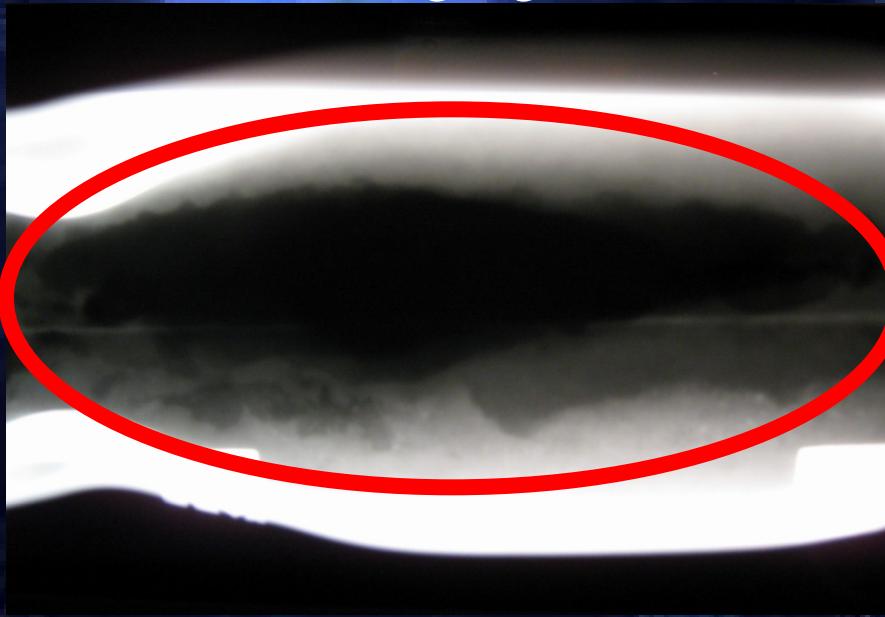
Fig.(11) : X –Ray photo of the failed tube revealed heavy damage due to the corrosion phenomena on the internal surface of the tube with severe reduction in thickness as shown in the red circle.

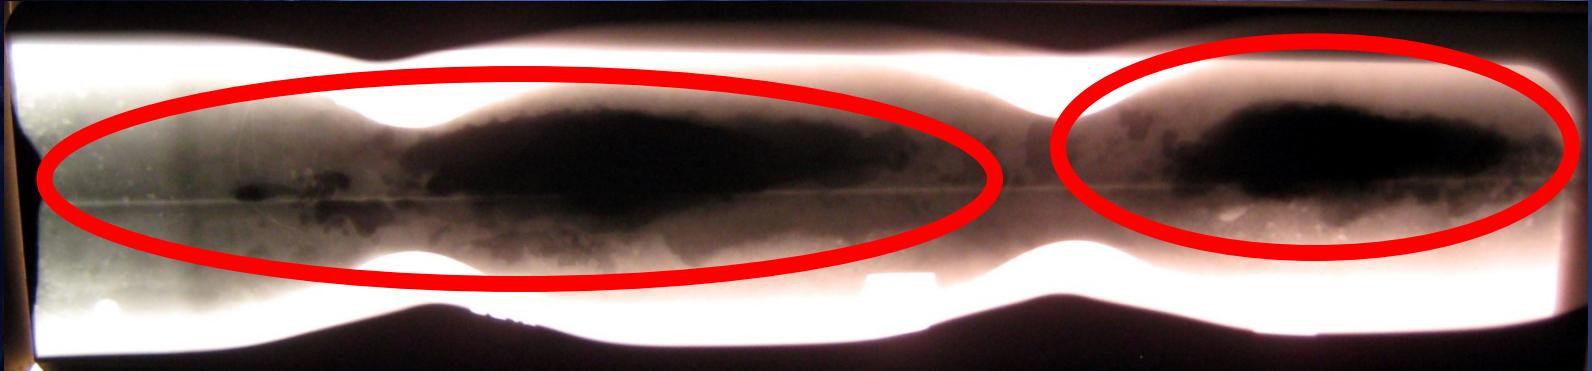
Fig.(12) : X –Ray photo of the failed tube revealed heavy damage due to the corrosion phenomena on the internal surface of the tube with severe reduction in thickness as shown in the red circle.

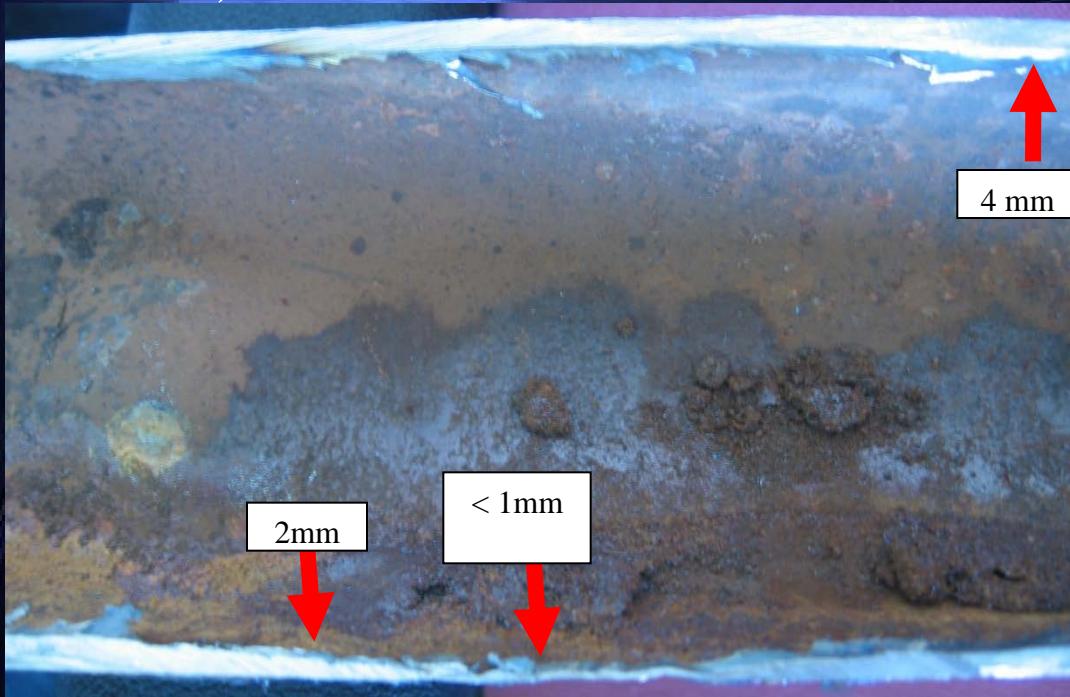
Fig.(13) : Red arrows reveals severe reduction in thickness in the lower part in comparison with the upper part.

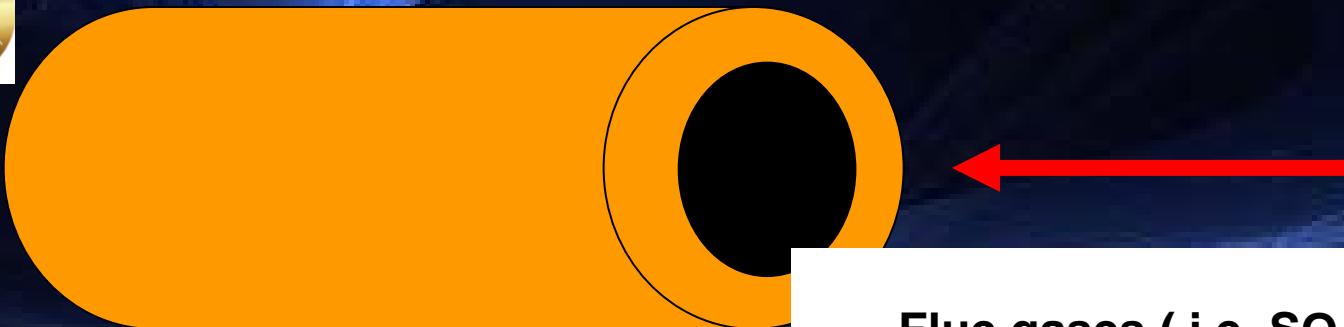
Flue gases (i.e. SO_2 , CO_2)

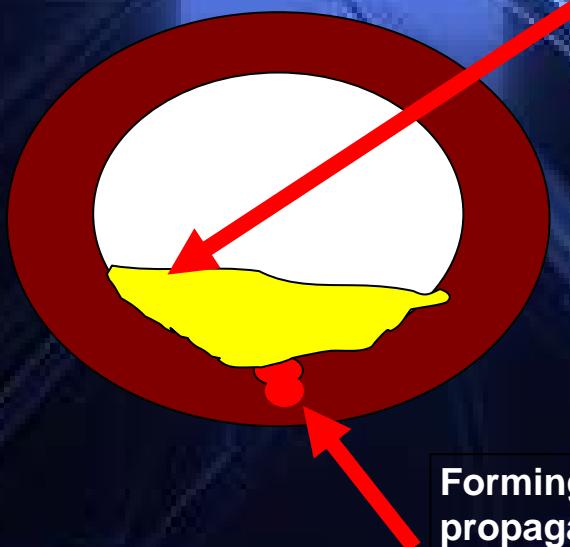
Forming a pit that
propagates into
worm holes causing
full deterioration of
the material

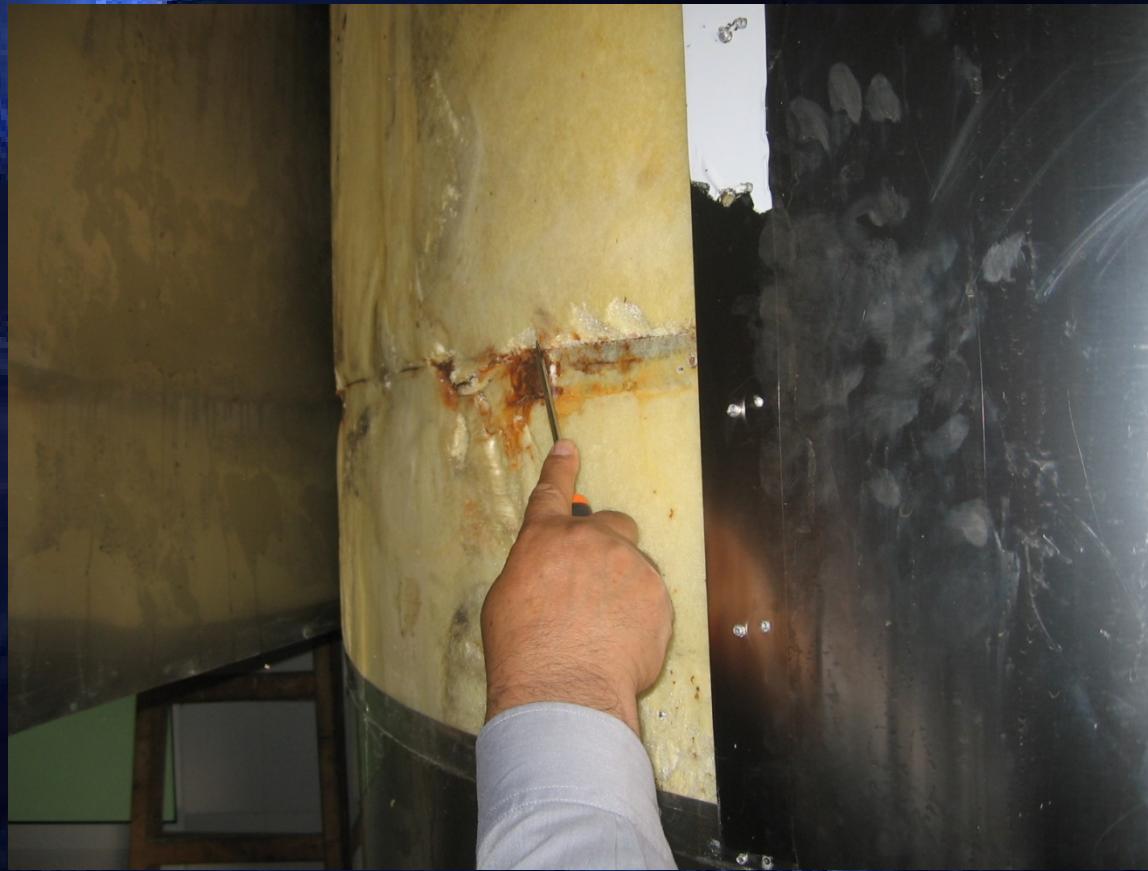
Fig.(2) : Corrosion products are very obvious below the external surface of the stainless steel sheets which appeared in the four above mentioned tanks.

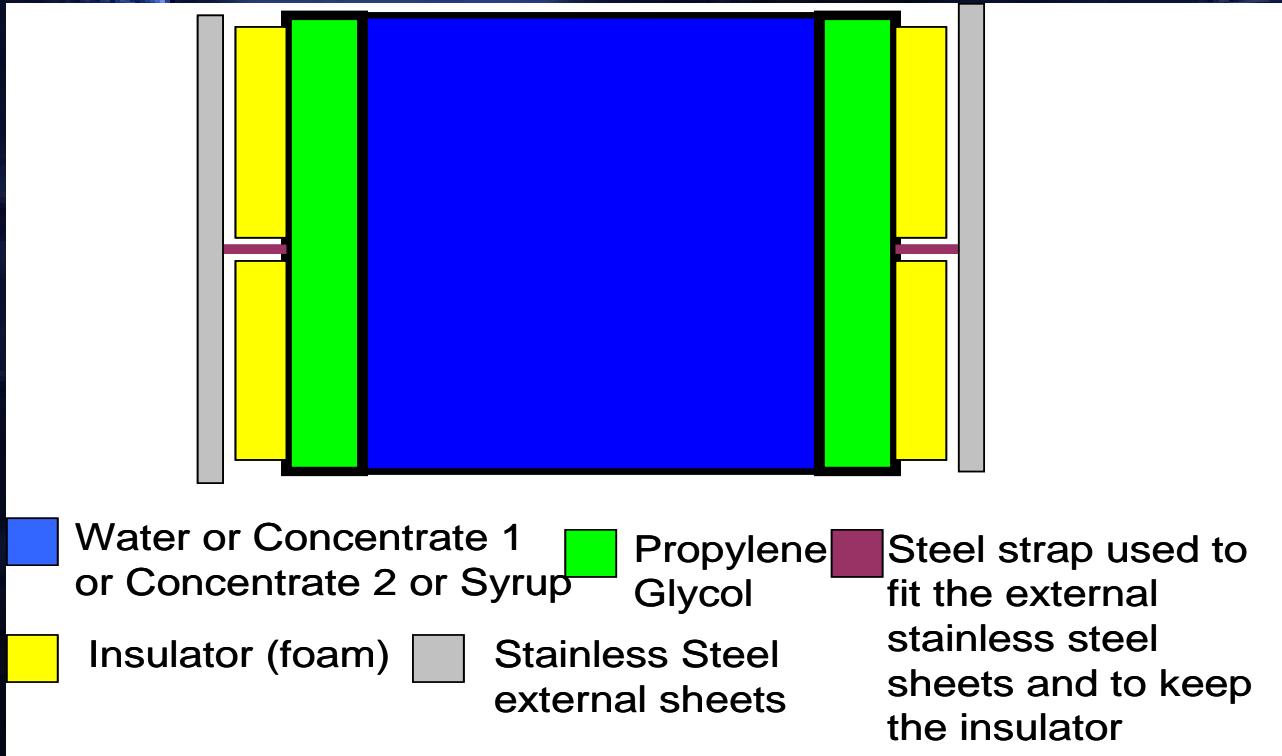
Fig.(3) : Crrossectional area of the tanks

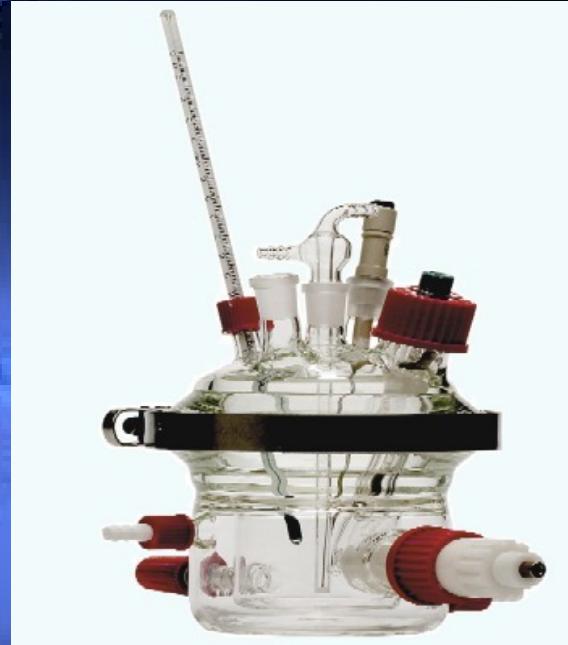
Fig.(4) : Corrosion Cell

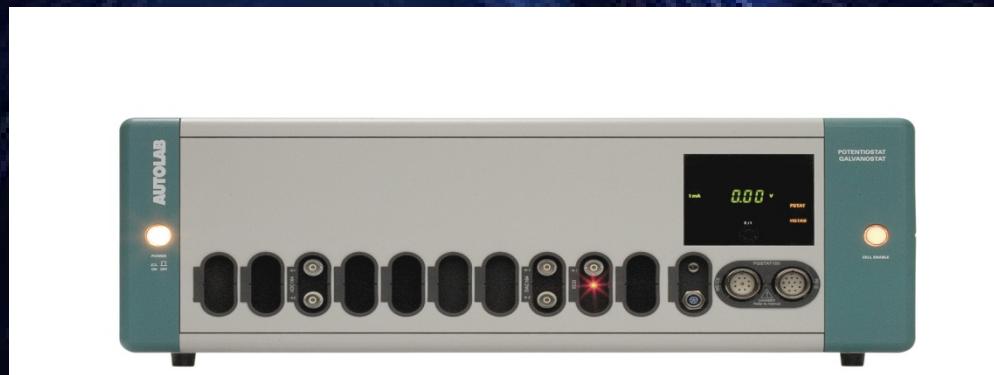
Fig.(5) : Potentiostat

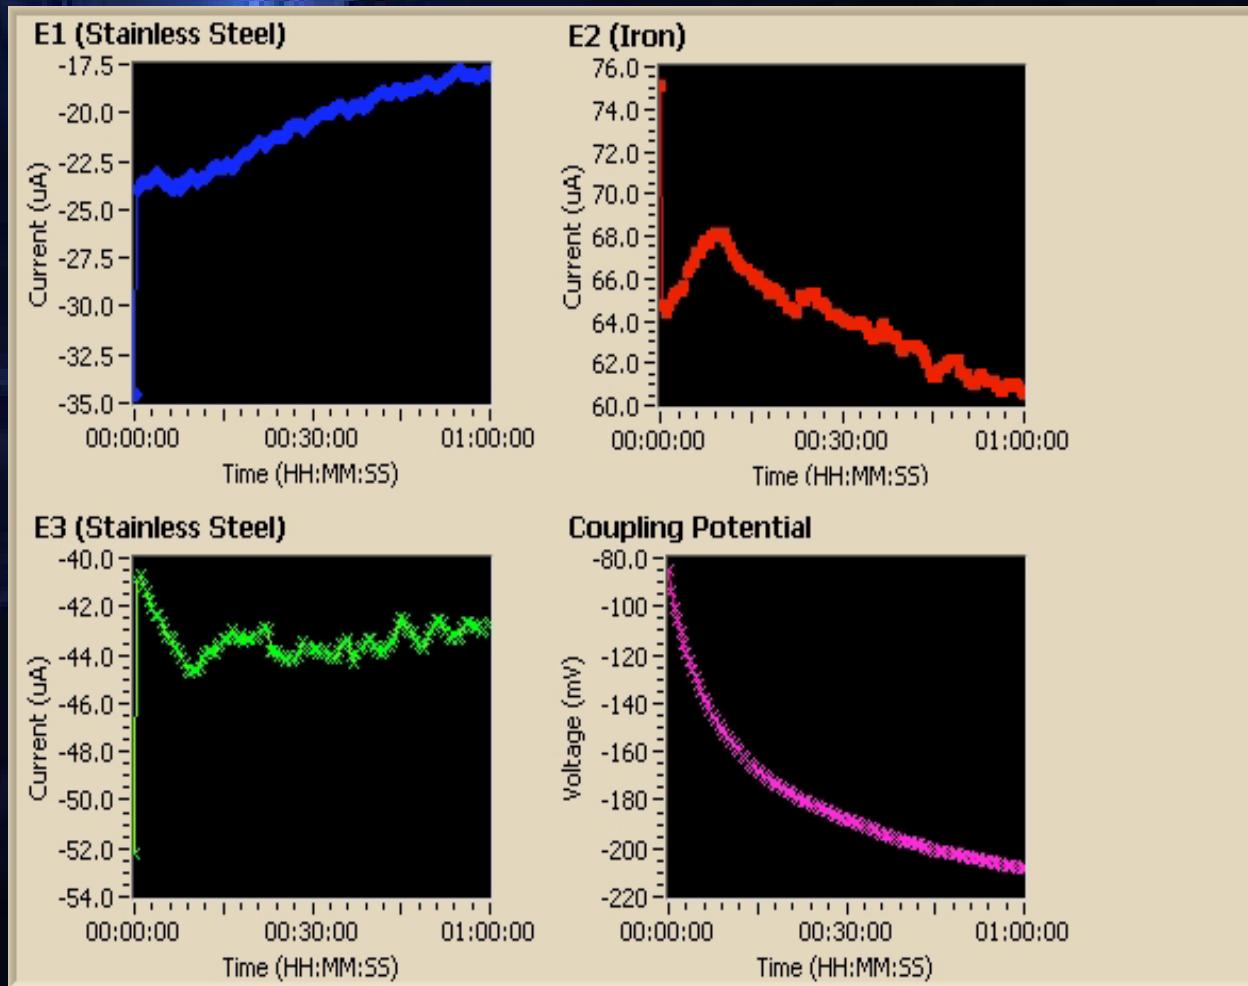
Fig.(7) :Galvanic corrosion result due to the coupling of stainless steel sheets (SS 304) , stainless steel (SS304)of the outer surface of the jacketed tank and carbon steel straps.

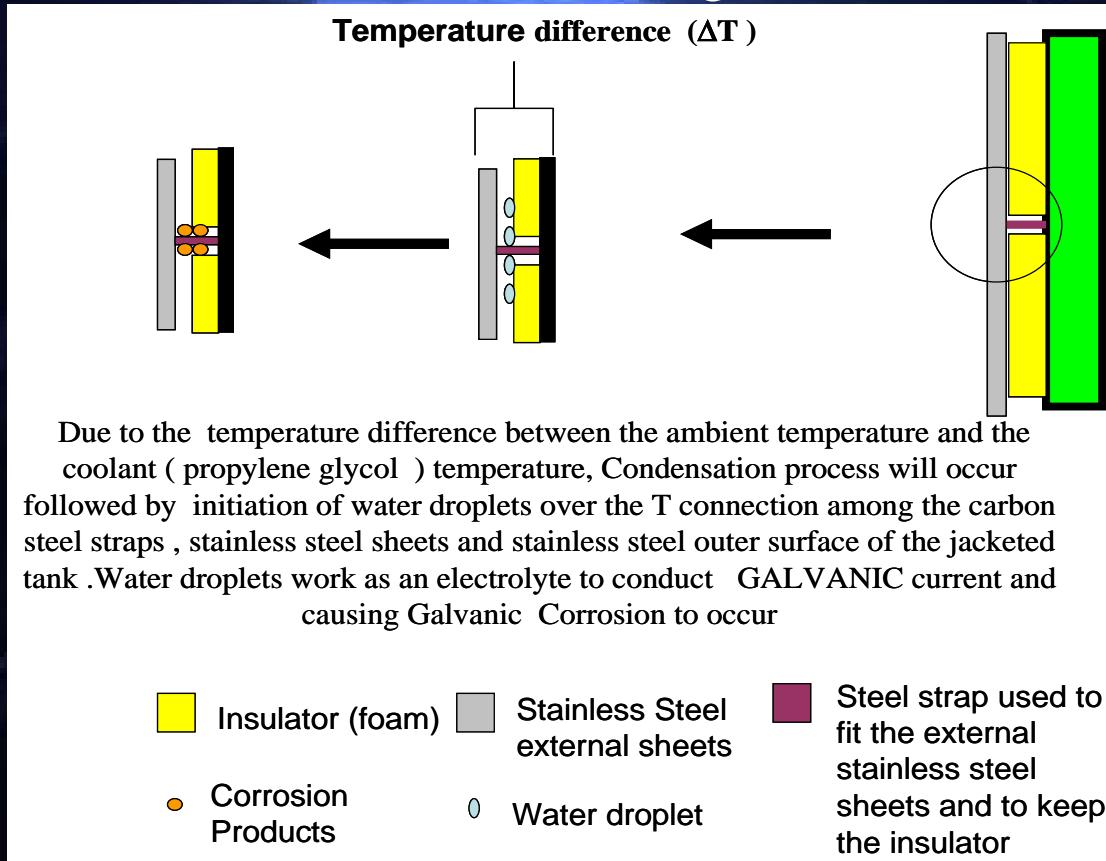
Fig.(6) :sketch shows the major cause of corrosion beneath the stainless steel sheets

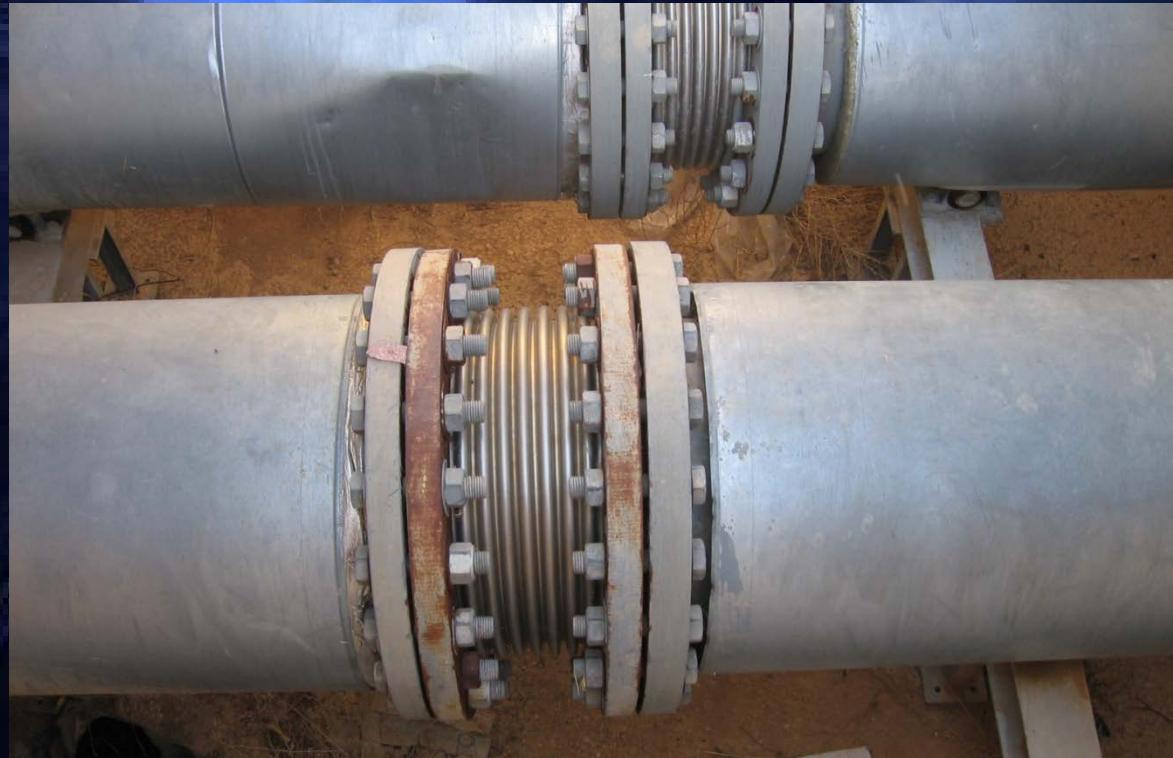
Fig.(1): Expansion joints
