Diagnosing and Solving Corrosion Problems in Jordanian Industry (Case Study)

Farqad Al-Hadeethi

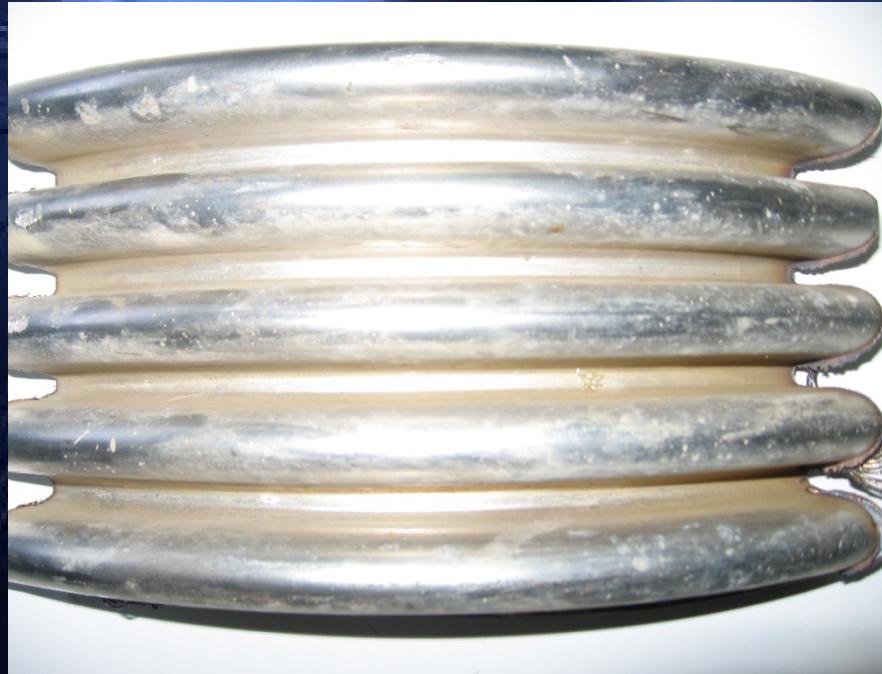
Fig.(2):Sample of expansion joint

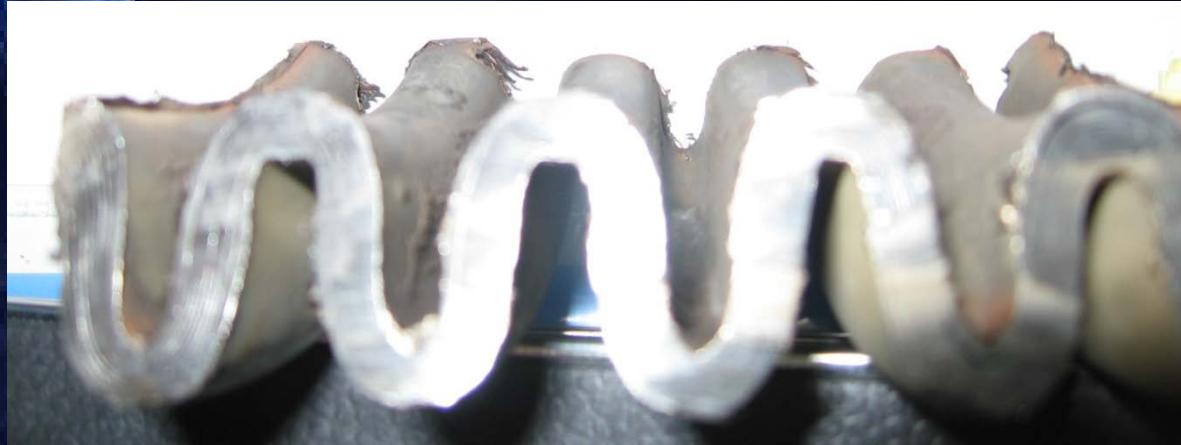
Fig.(3): Sample of expansion joint showing the stainless steel 304 layers compressed together.

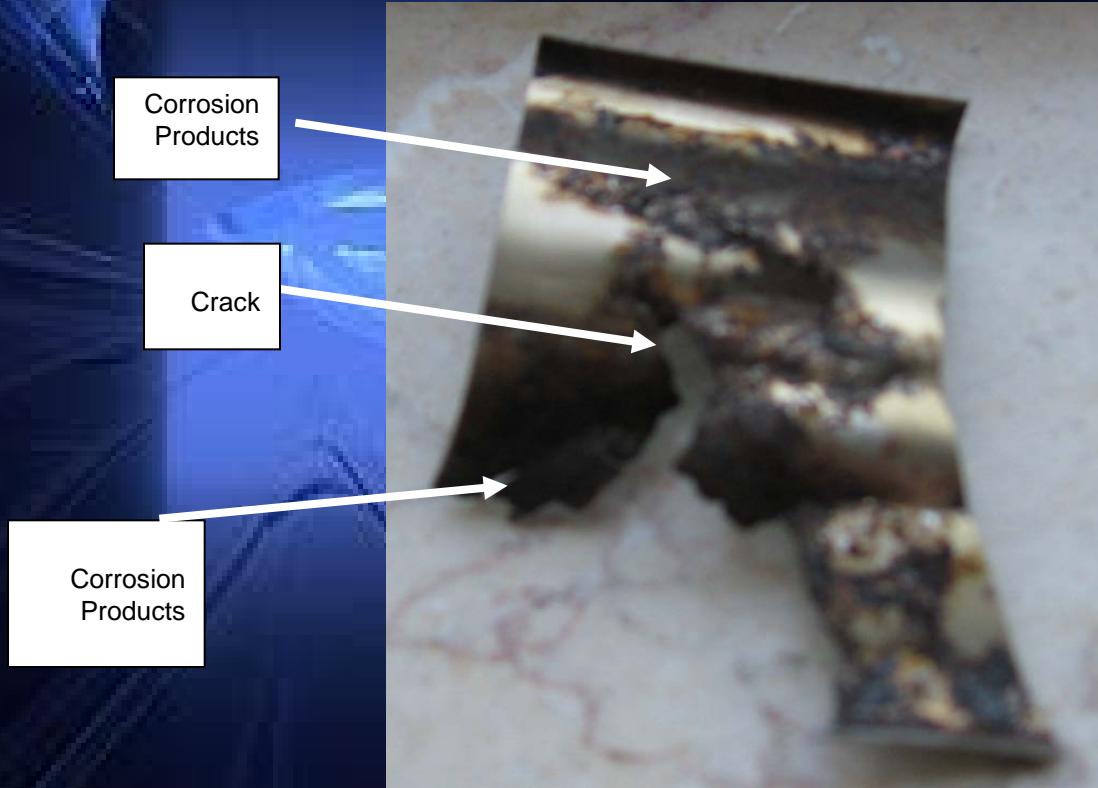
Fig.(4): Sample of one of the corroded layers in the expansion joint given in fig.(3).

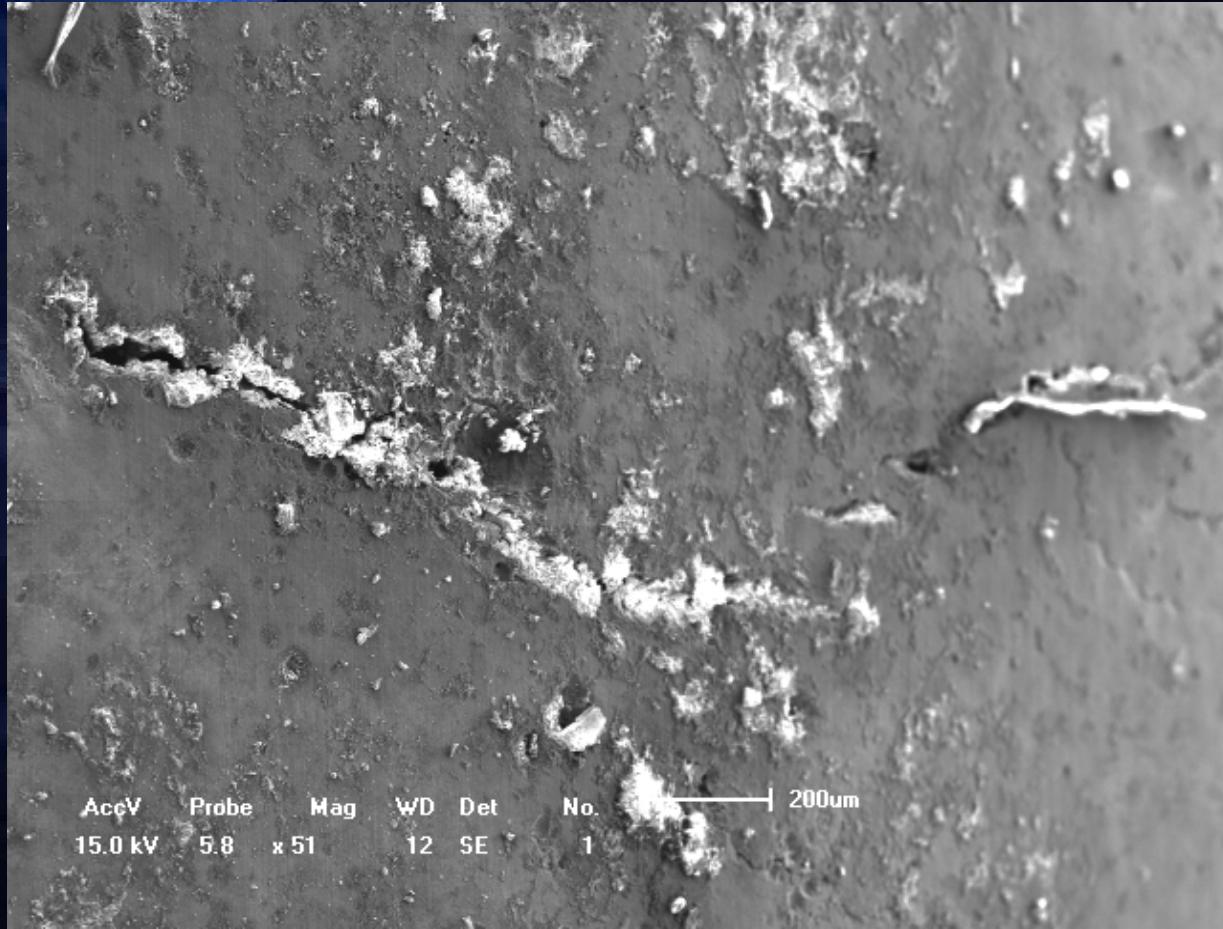
Fig.(5):SEM photo of one of the corroded layers in the expansion joint showing a crack occurred due to the Stress Corrosion Cracking (SCC).

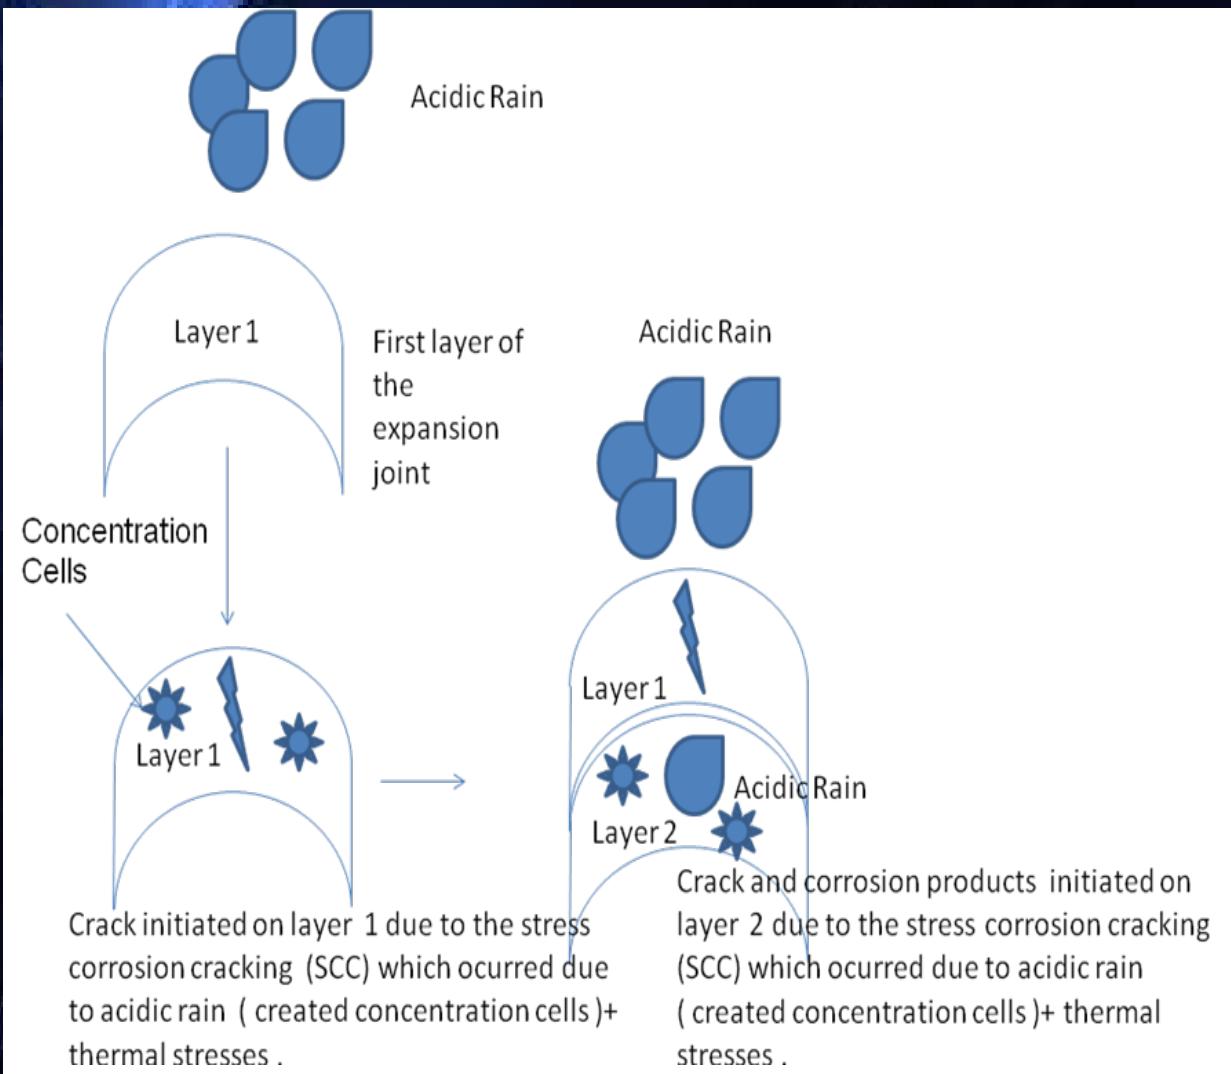
Fig.(3):Schematic representation to what have happened to the expansion joint.

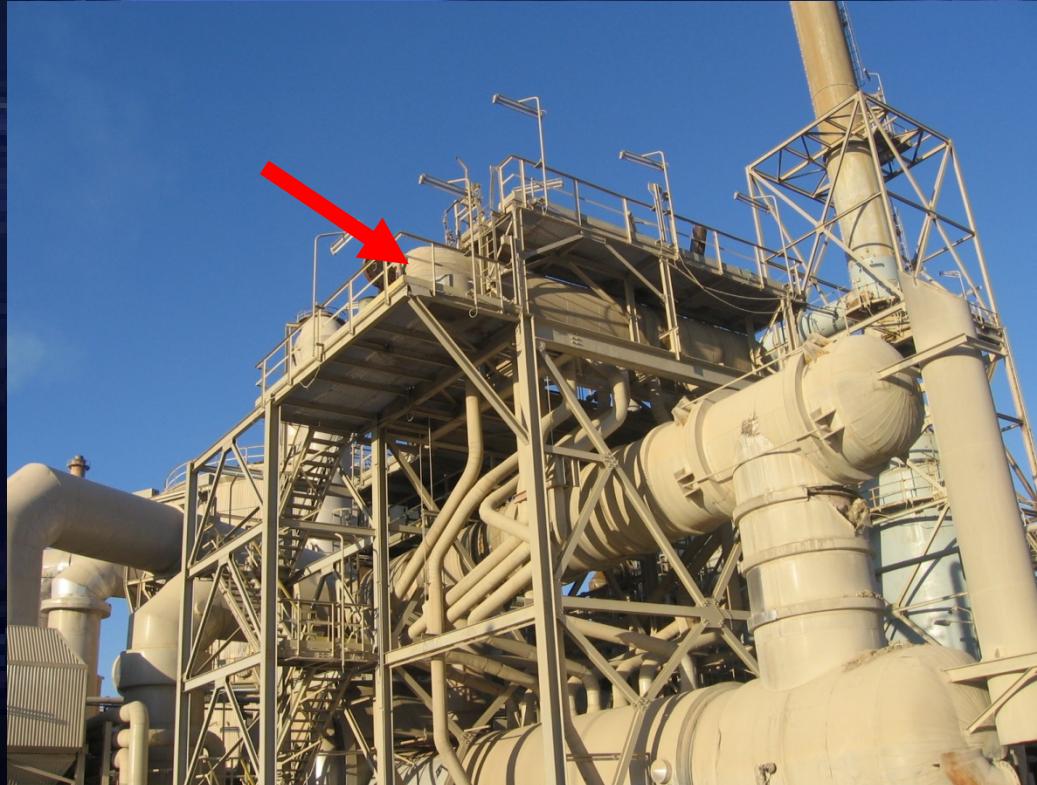
Fig.(1) : Steam drum

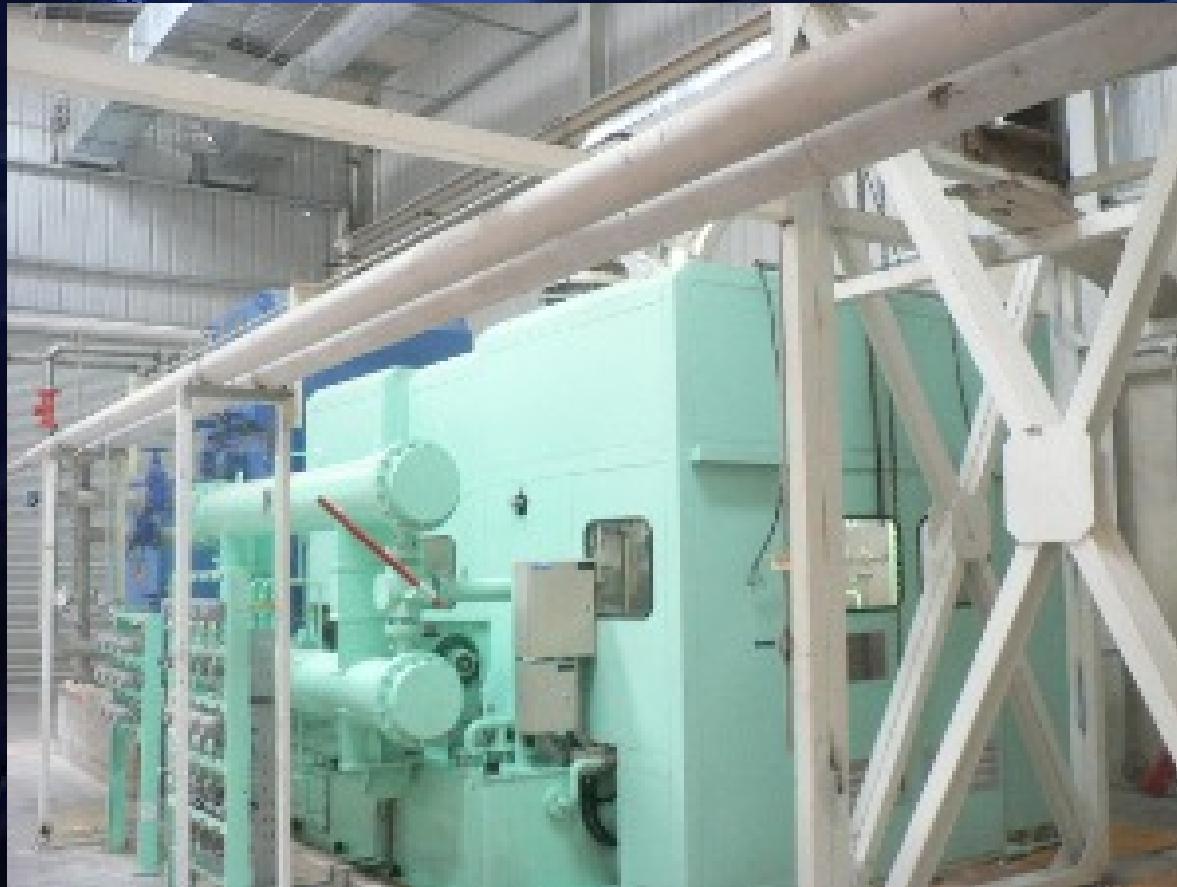
Fig.(1) : Steam Turbine of the National Sugar Company.

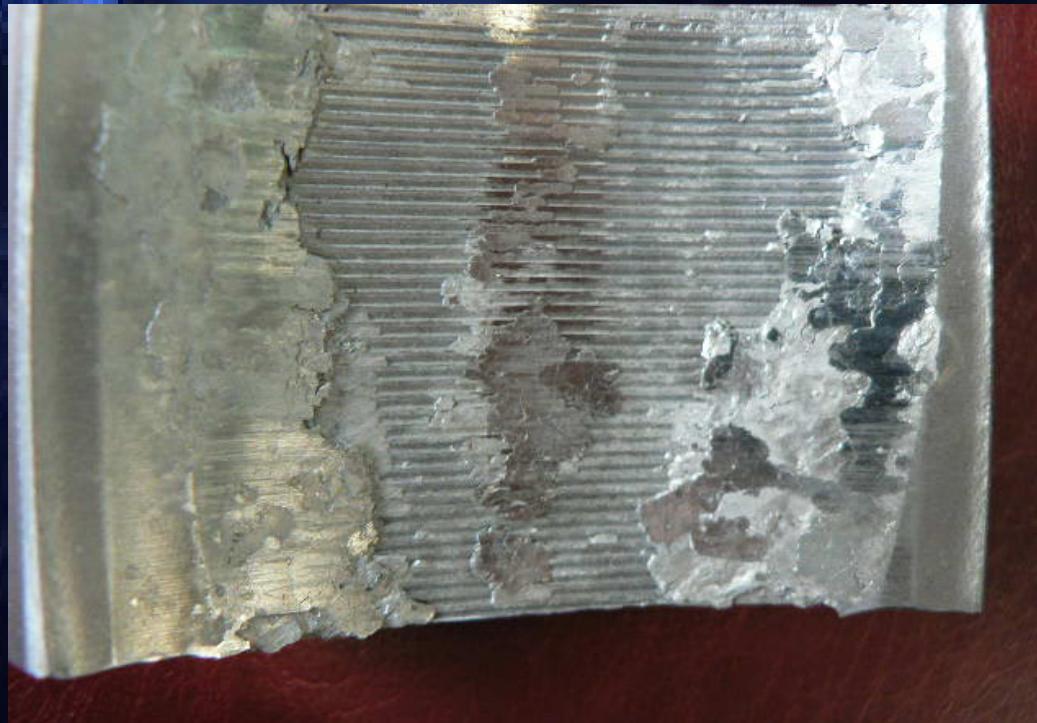
Fig.(2) : Part of the failed bearing no.1

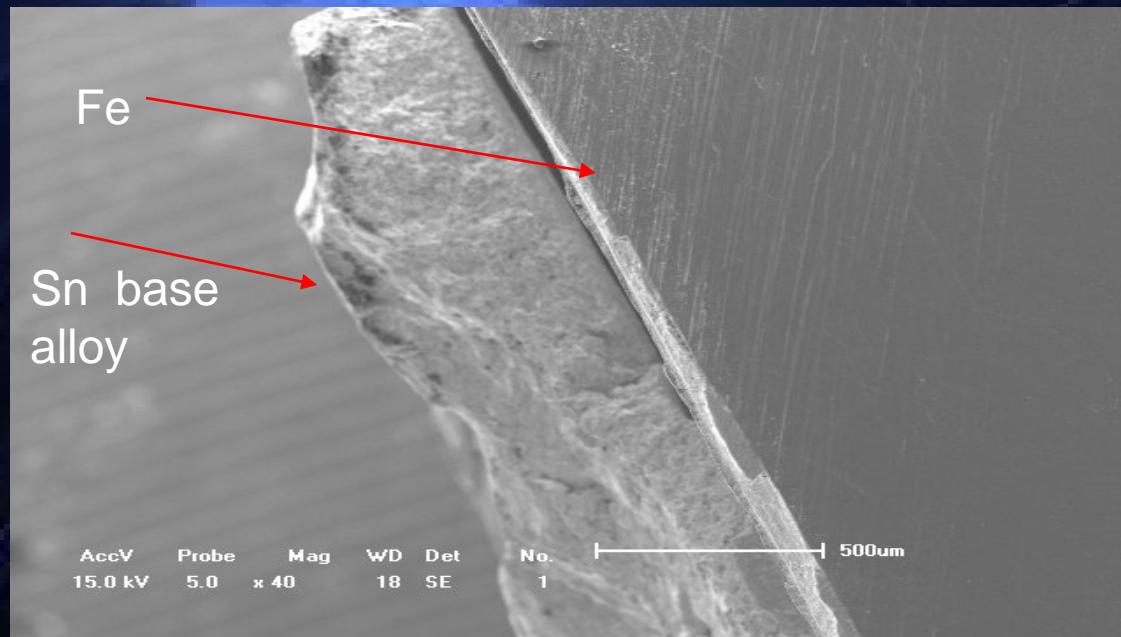
Fig(3) : Part of the failed bearing no.1 magnified using SEM (40 X) showing the layer of Tin base alloy covering the base metal constructed of Iron (Fe)

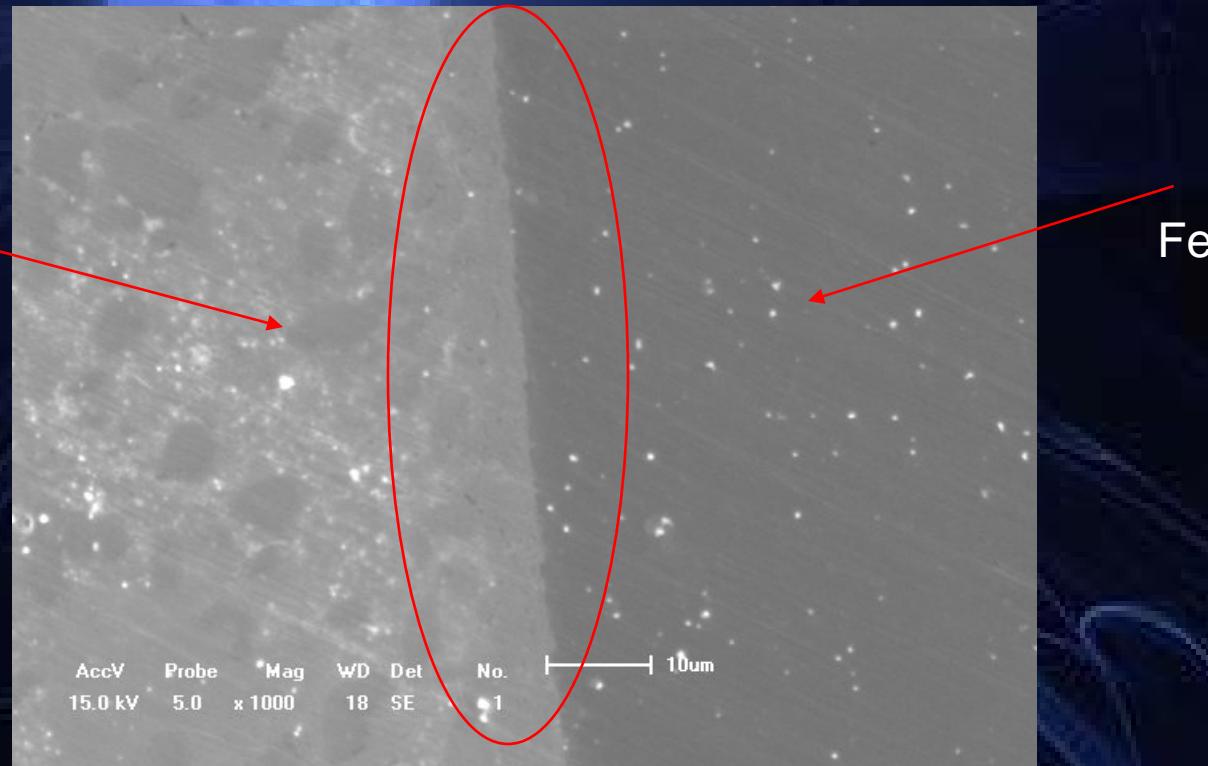
Fig.(4) : Part of the failed bearing no.1 magnified using SEM (1000 X) showing the Iron-Tin base alloy interface.

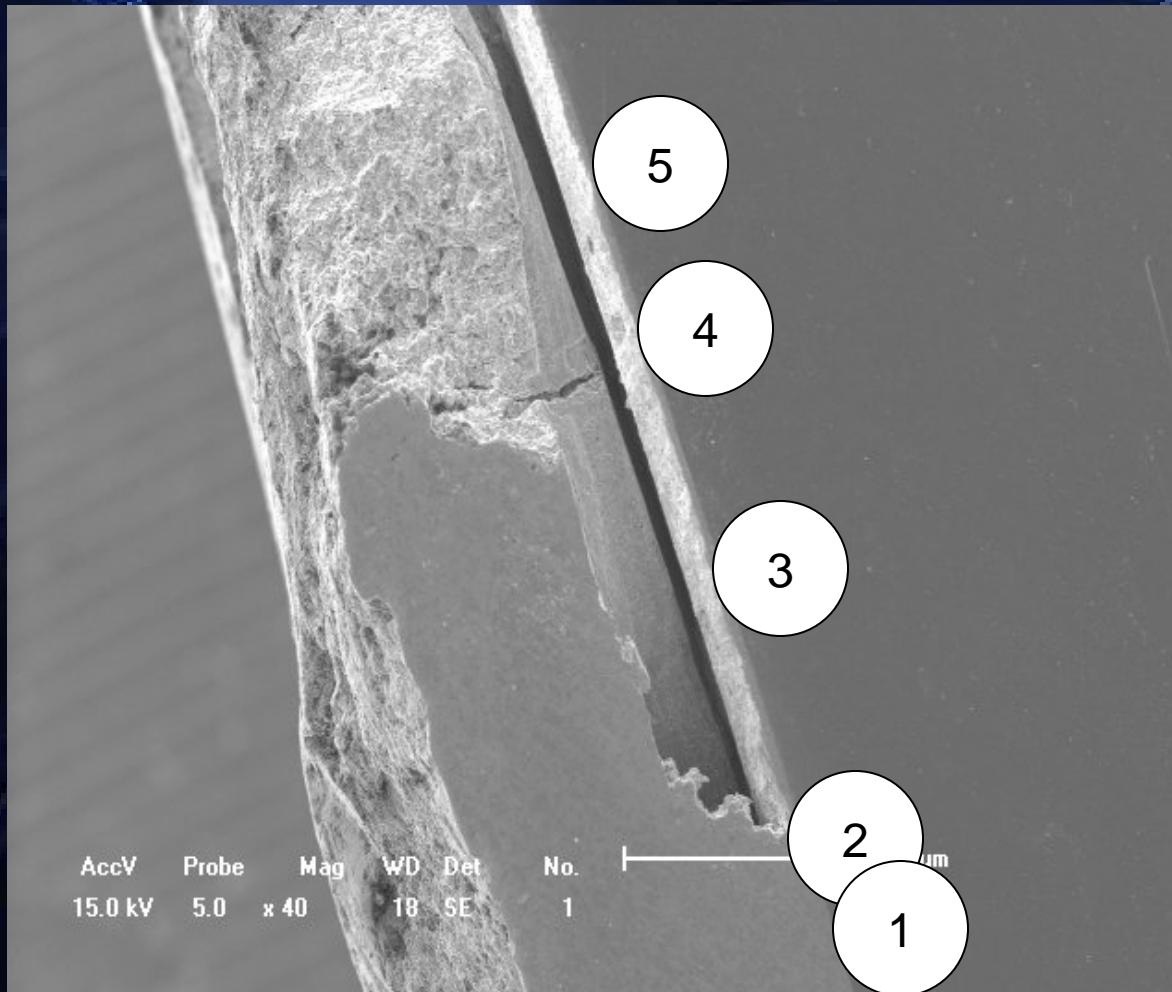
Fig.(5): Selected positions at the metal - metal interface to conduct Hardness testing.

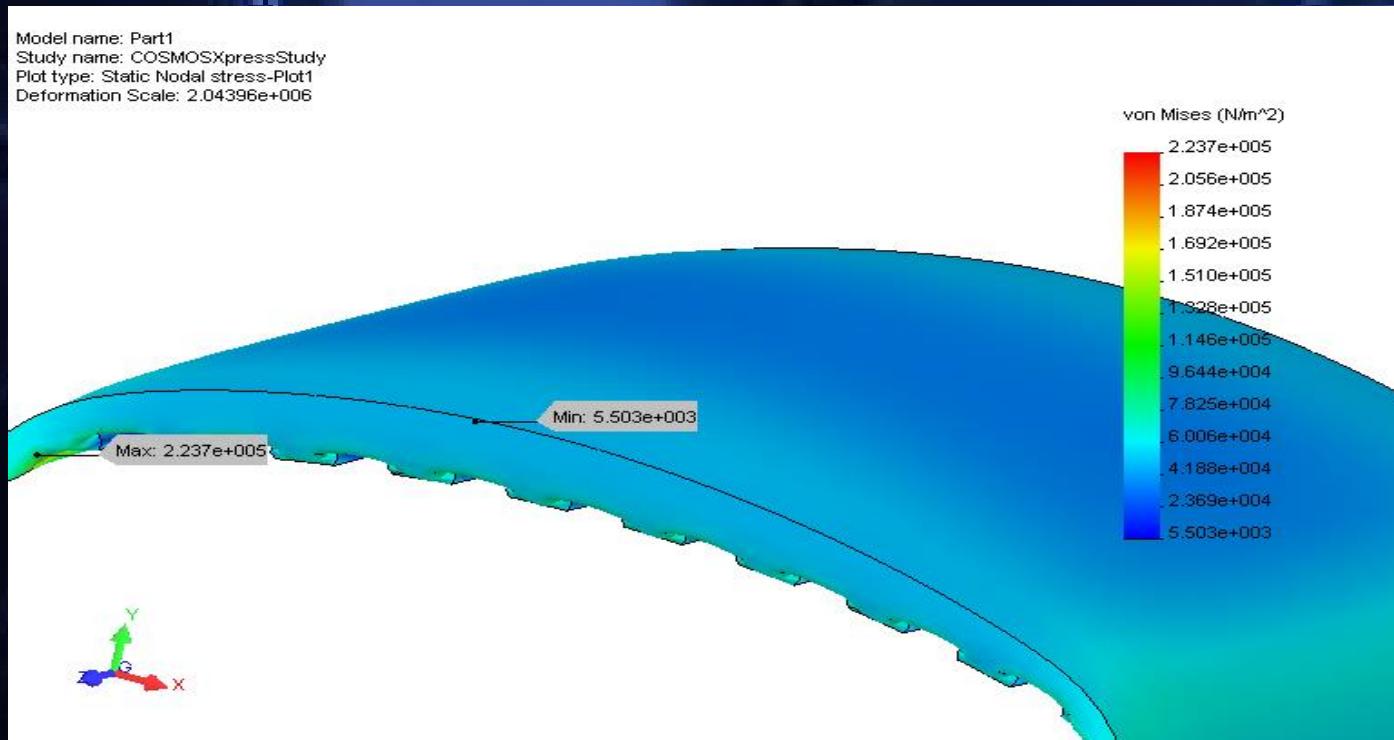
Fig.(6) : Finite Element Method using VON MISES method to determine the stresses subjected on the failed bearing revealed that the maximum stresses were concentrated at the left and right edges of the bearing while minimum stresses were concentrated near the middle of the bearing .

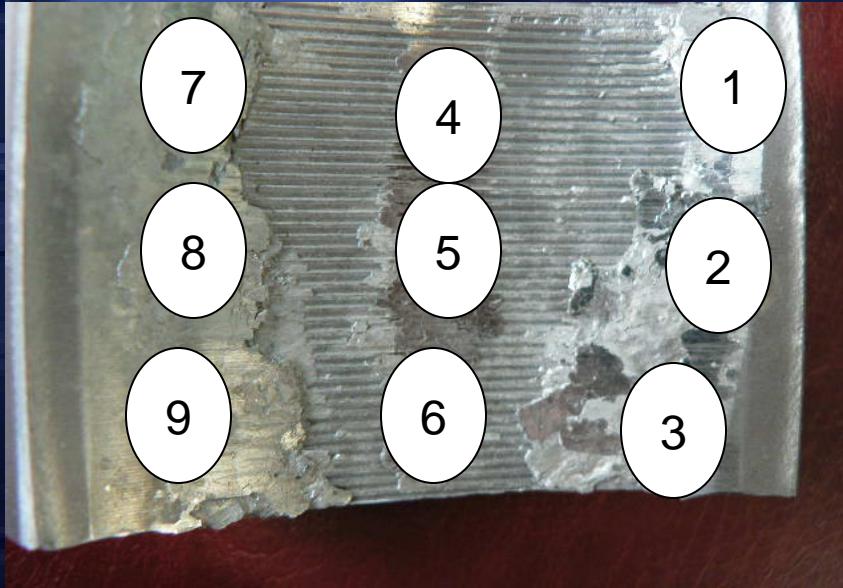
Fig.(7) : Part of the failed bearing no.1 showing the random selected spots in order to measure the thickness of the Tin base alloy layer

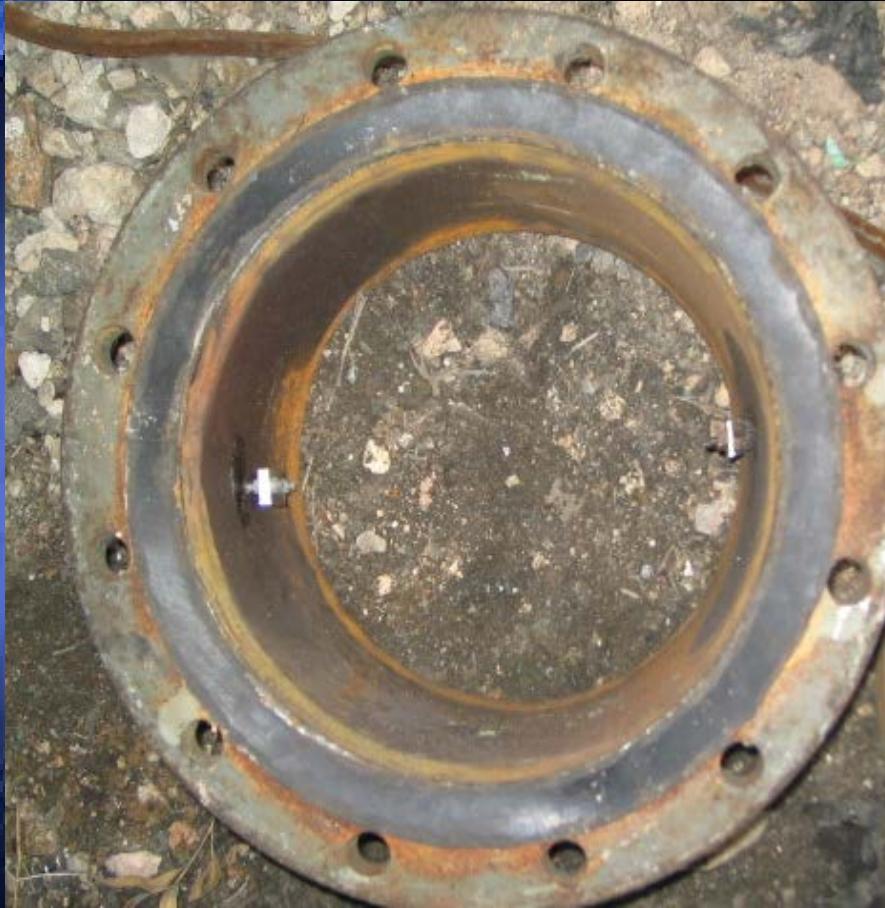
**Shows the installation of the
Corrosion Coupon and Scale
Coupon in 12 inch pipeline**

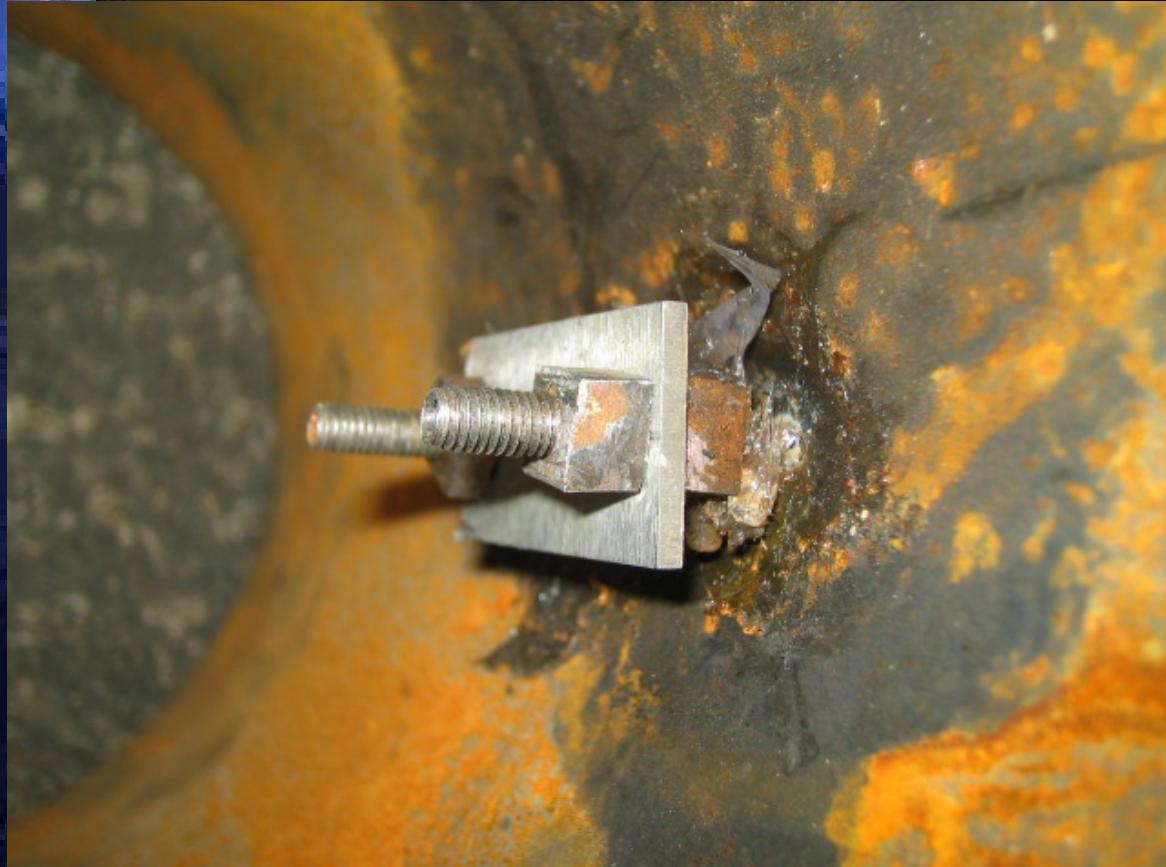
**Corrosion Coupon before
exposure**

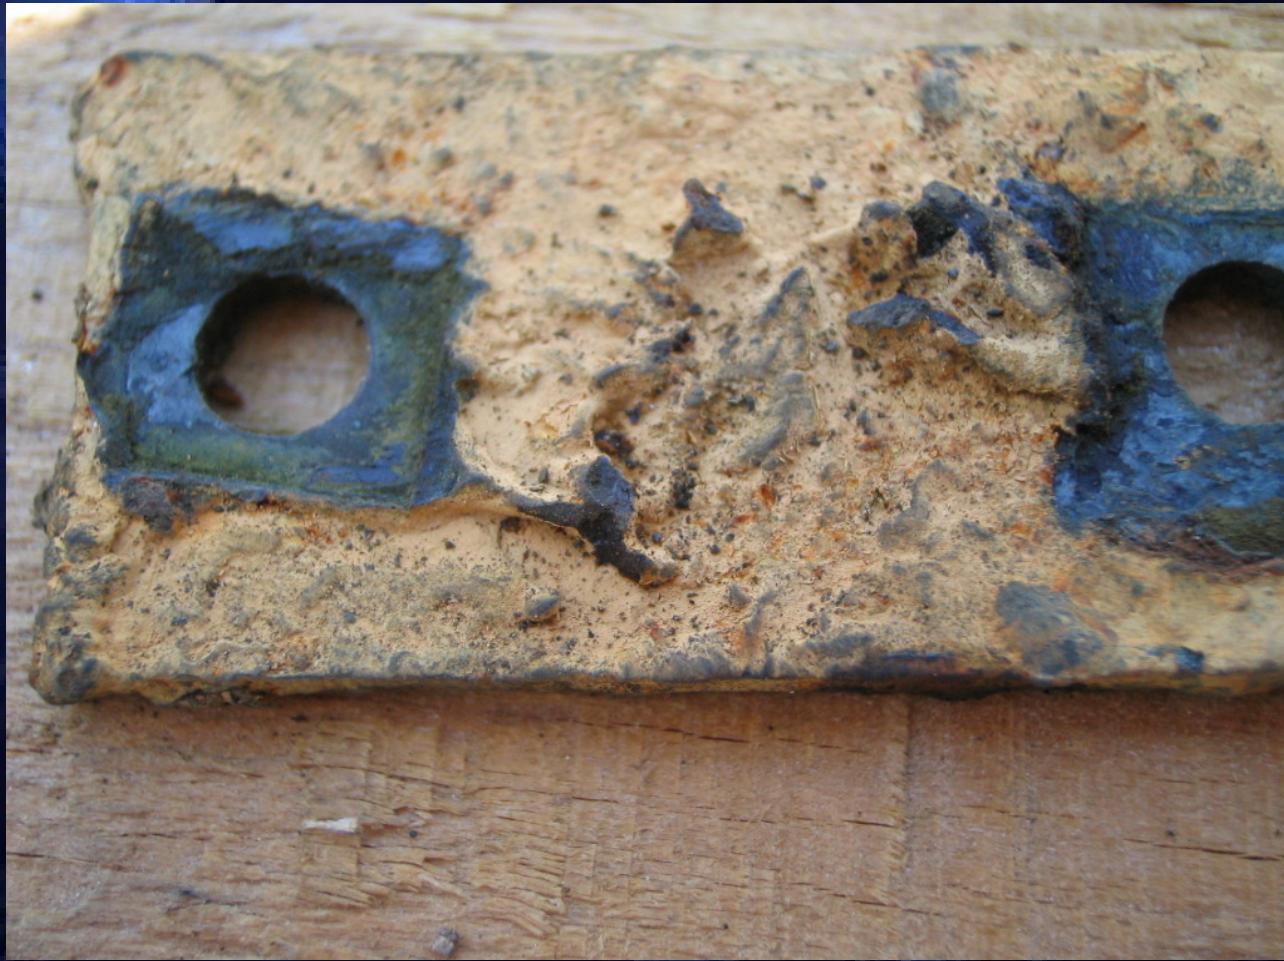
Corrosion Coupon after
exposure for six months

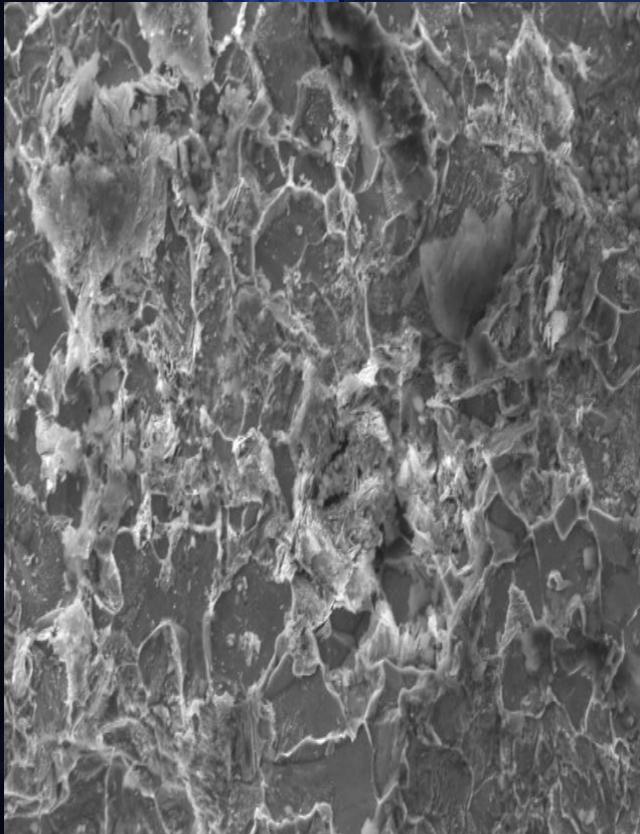
**SEM photo of the surface
of Corrosion Coupon after
removing products from
the surface**

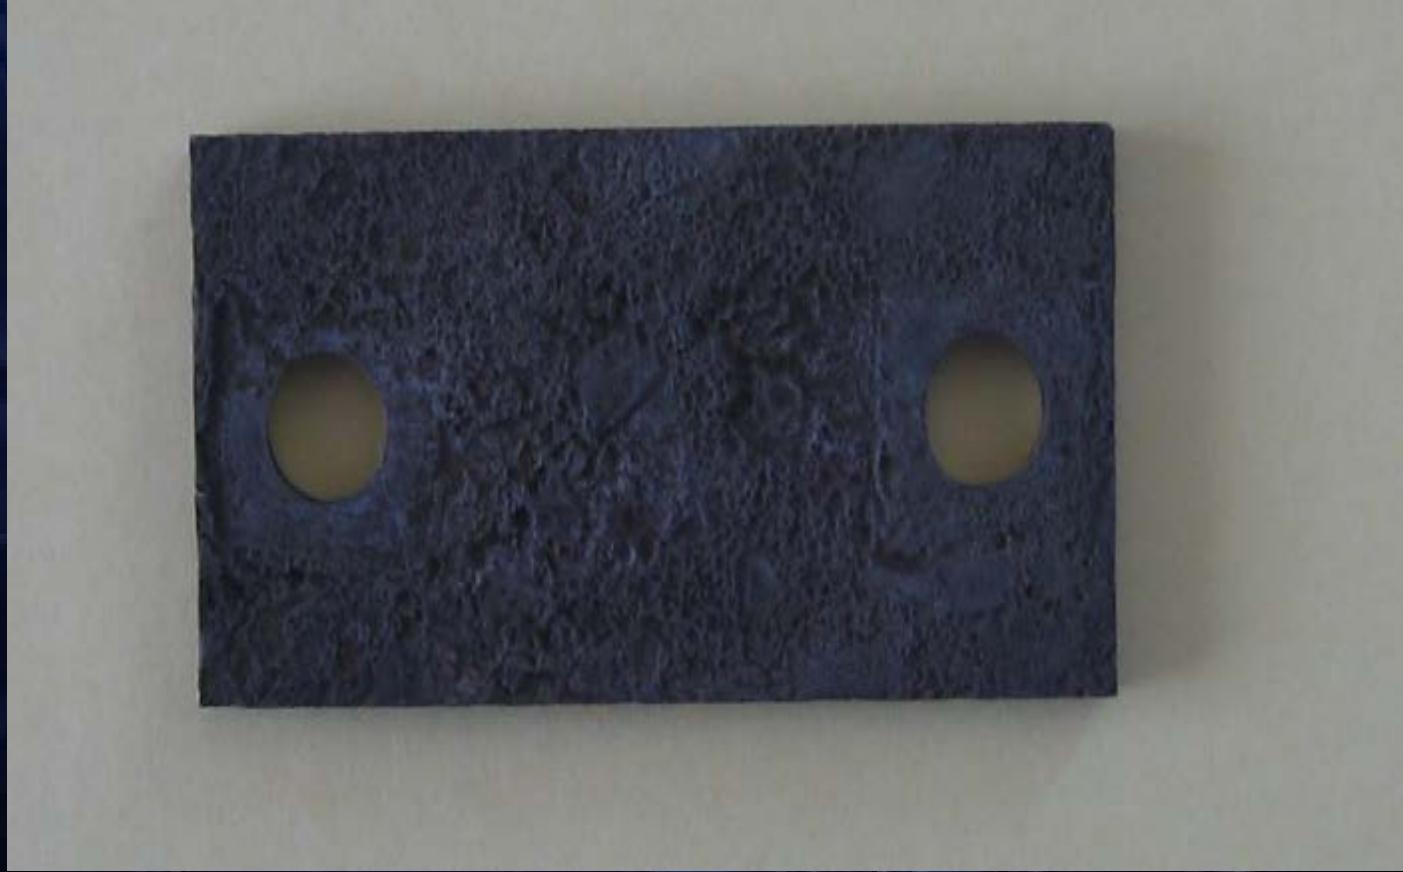
**Corrosion Coupon after removing
products from the surface**
