BPL Presentation for CORF

25 April 2007

Jim Mollenkopf, CURRENT Group

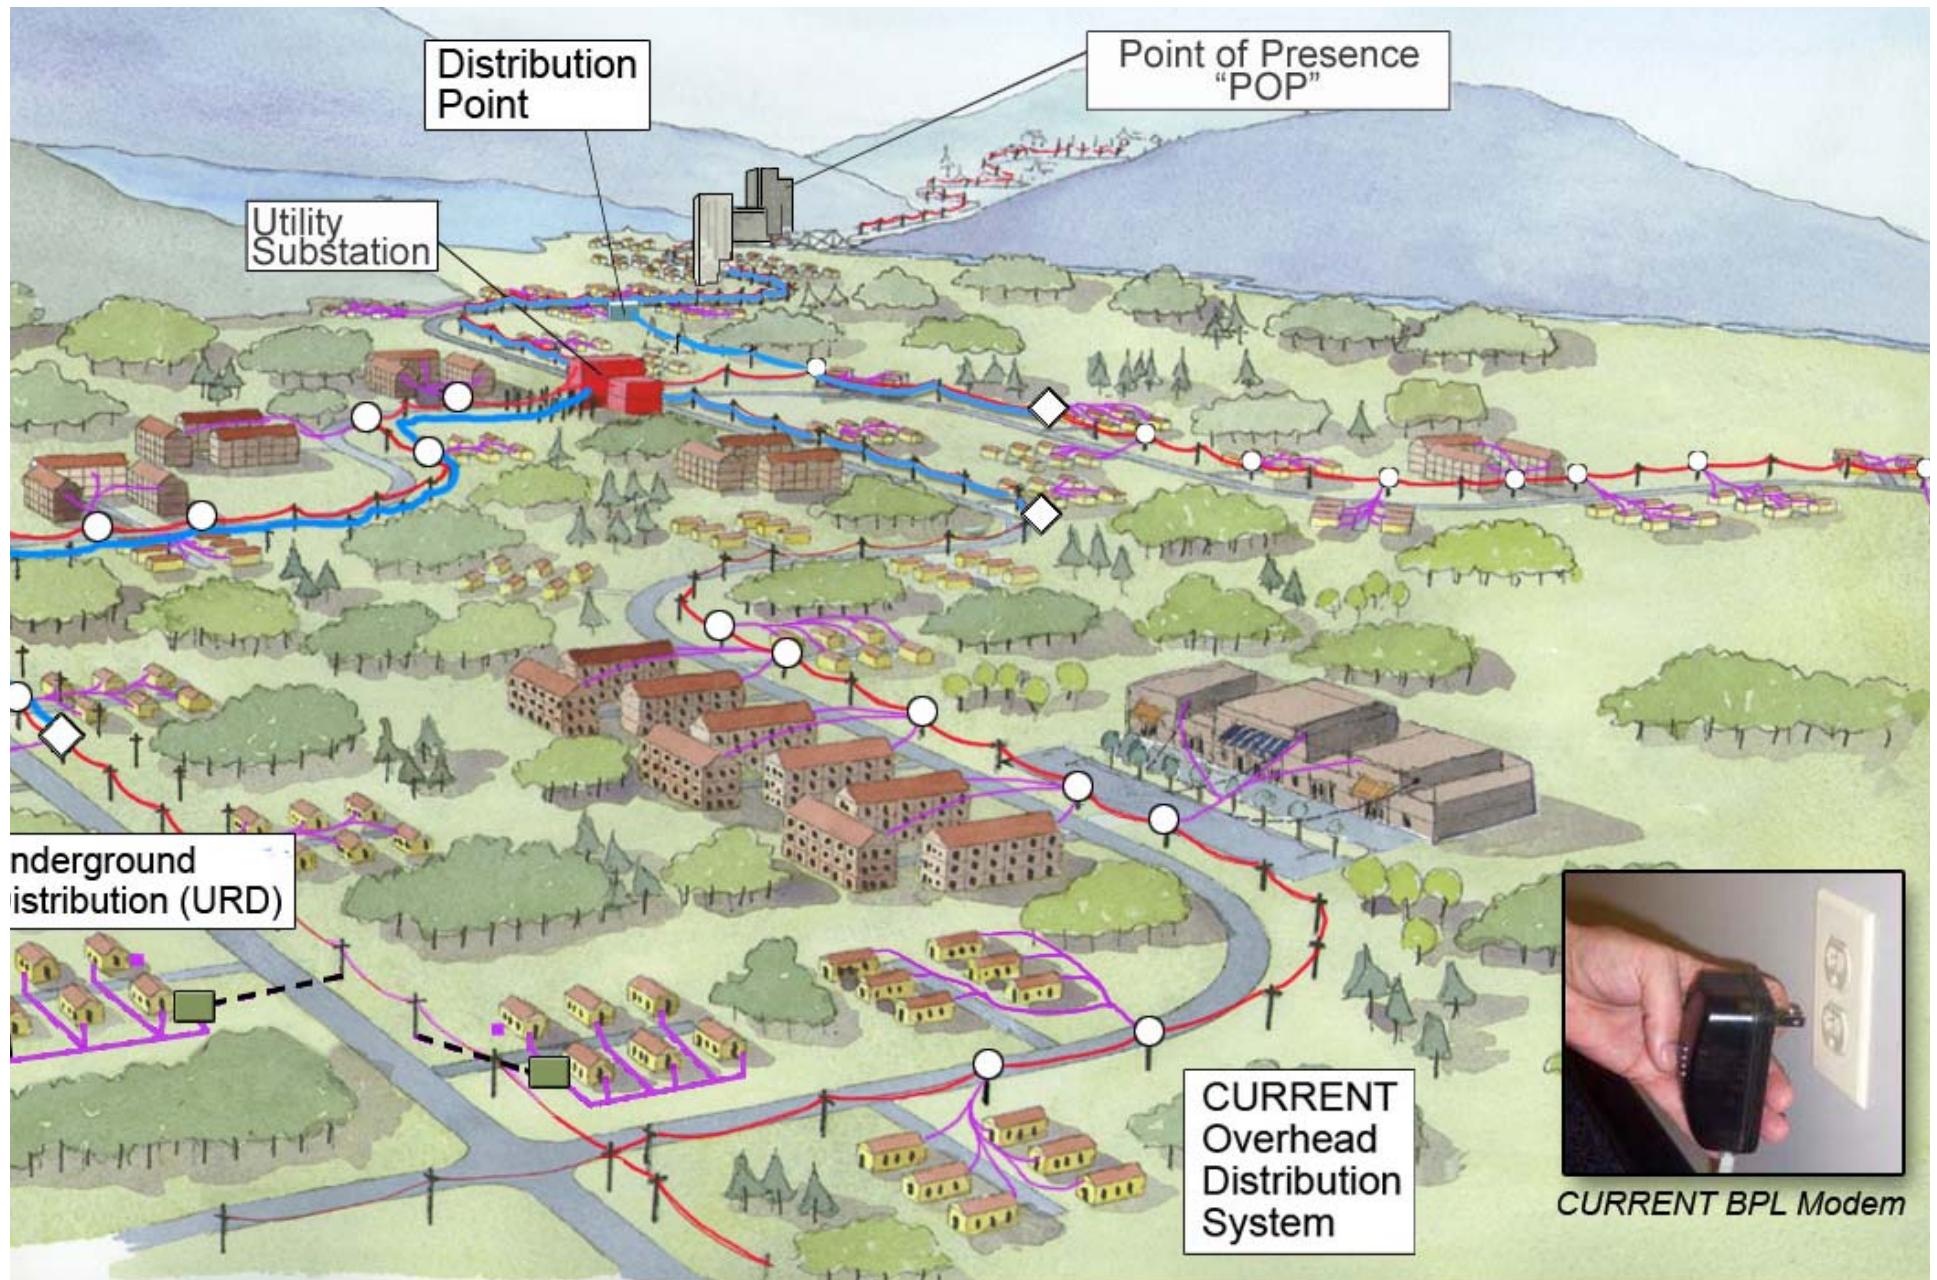
Pole Assembly
 haul-Point® Pole Assembly
 IIRD Assembly

CURRENT URD System

CURRENT OH System

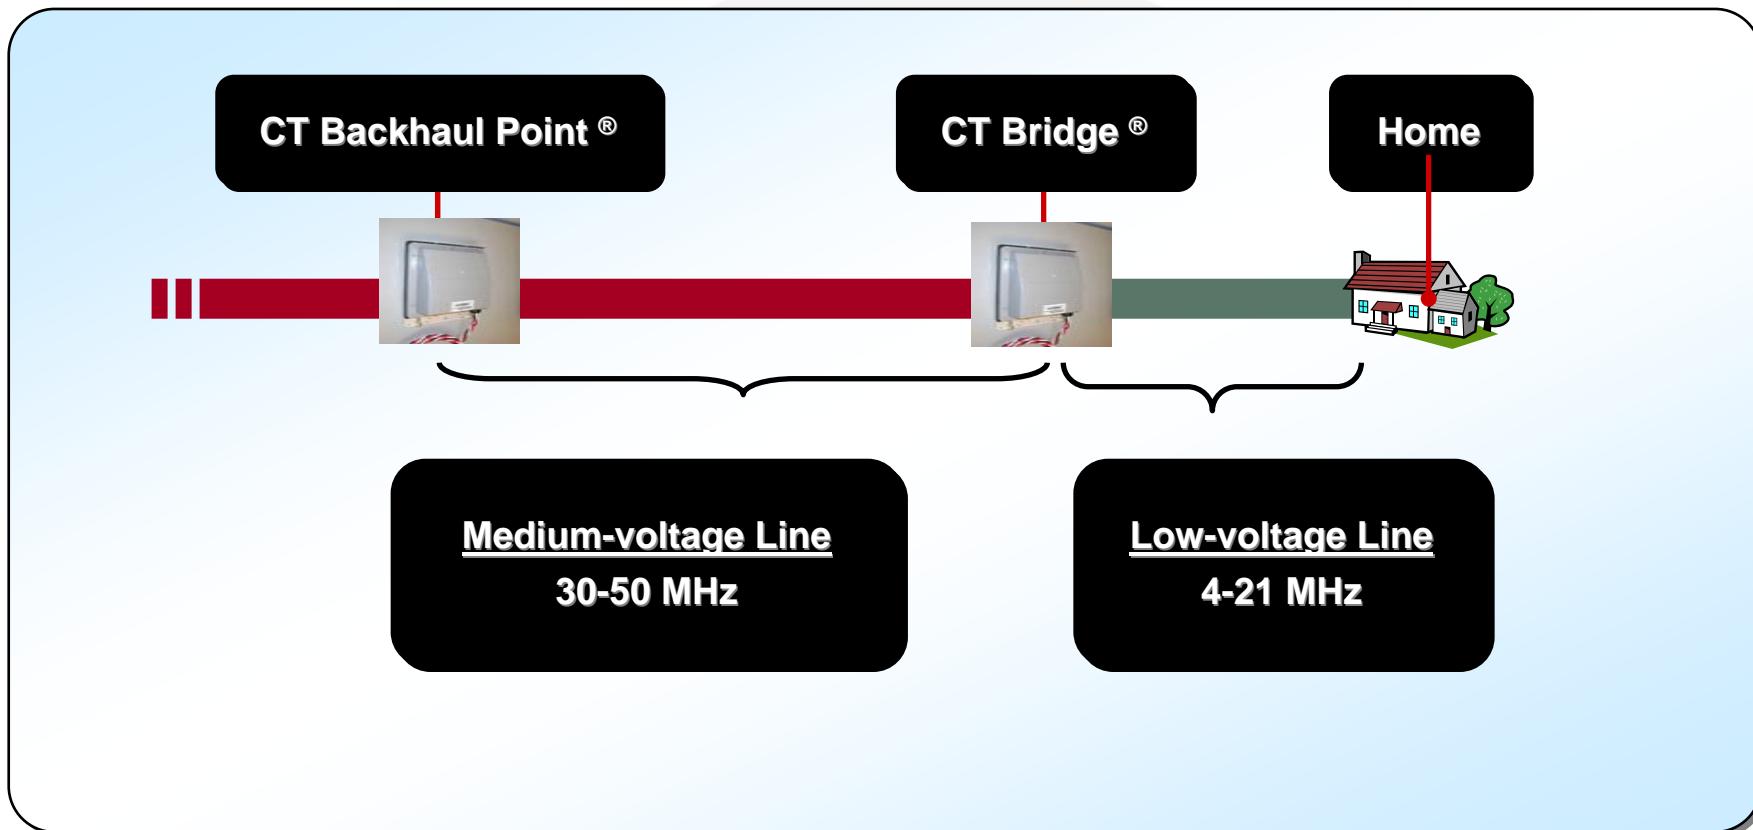
Use of HF frequencies avoided on MV lines

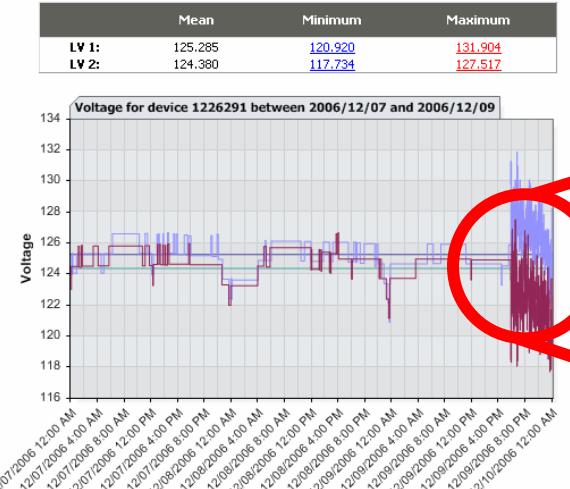
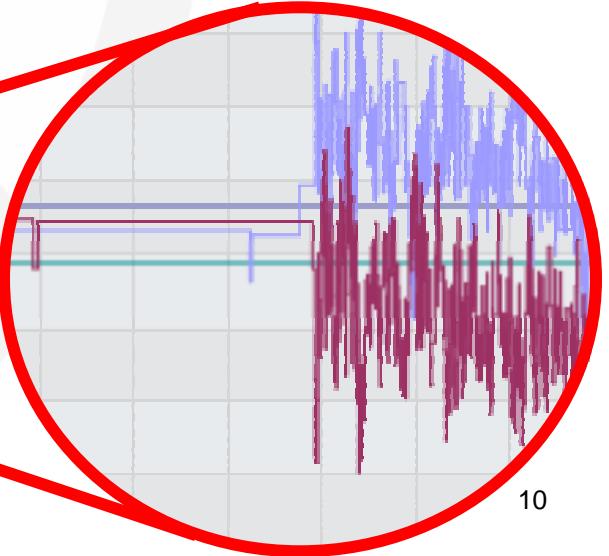
Voltage for device 1226291 between 2006/12/07 and 2006/12/09

What
happened
here?

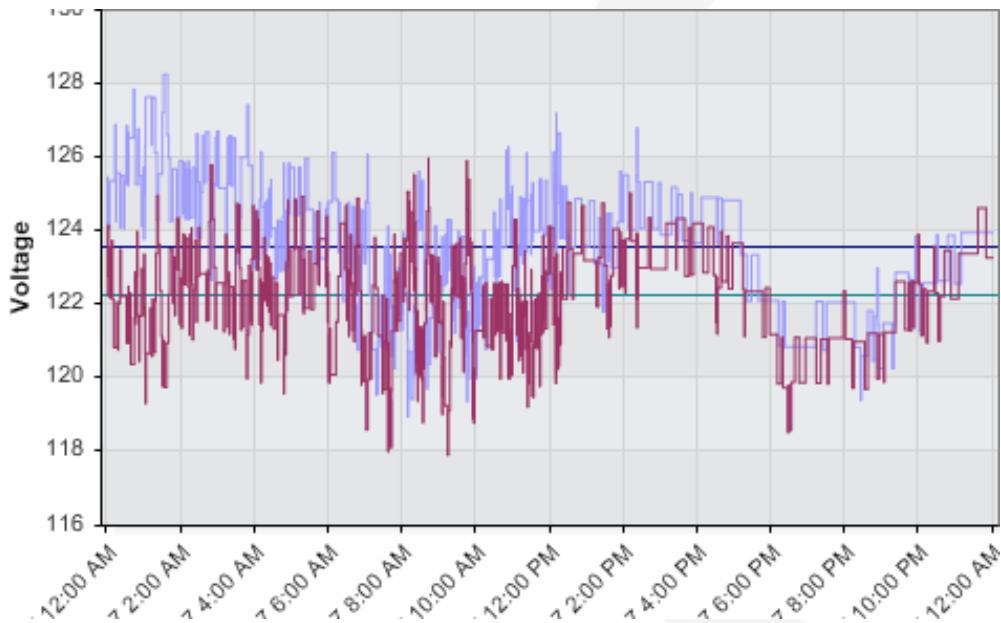
Voltage Data Before / After Repair

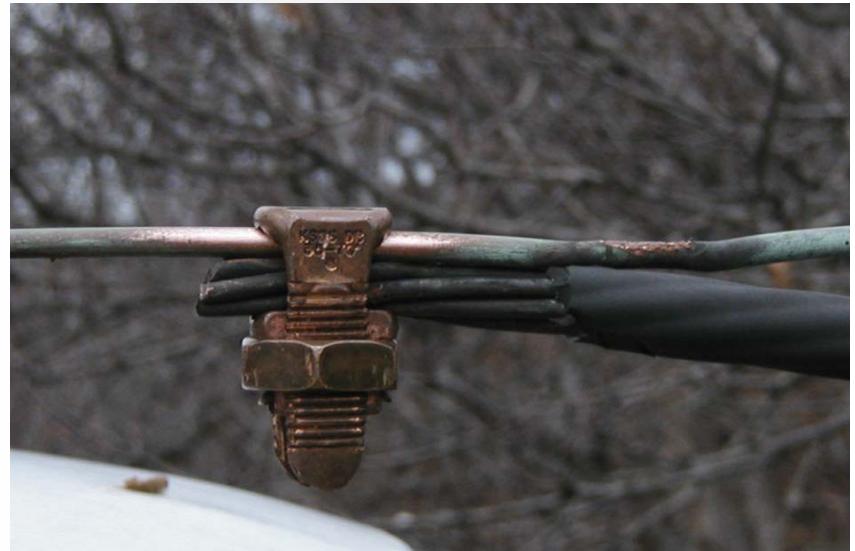
“During our field investigation a loose split bolt connection was found. The bad connection was between the 2/0 and #4 copper neutral”

Photo of Connection

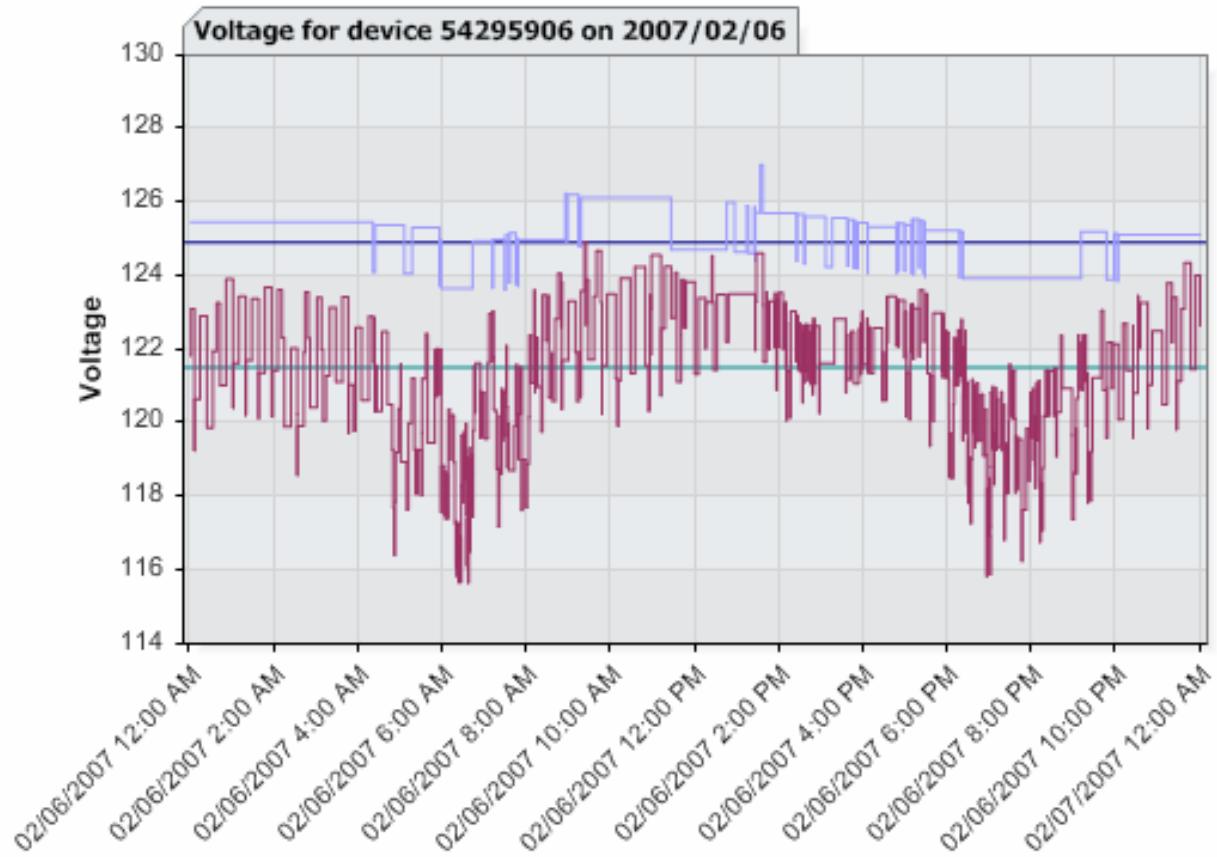
Investigation Trigger:
Current Look Low
Voltage Notification

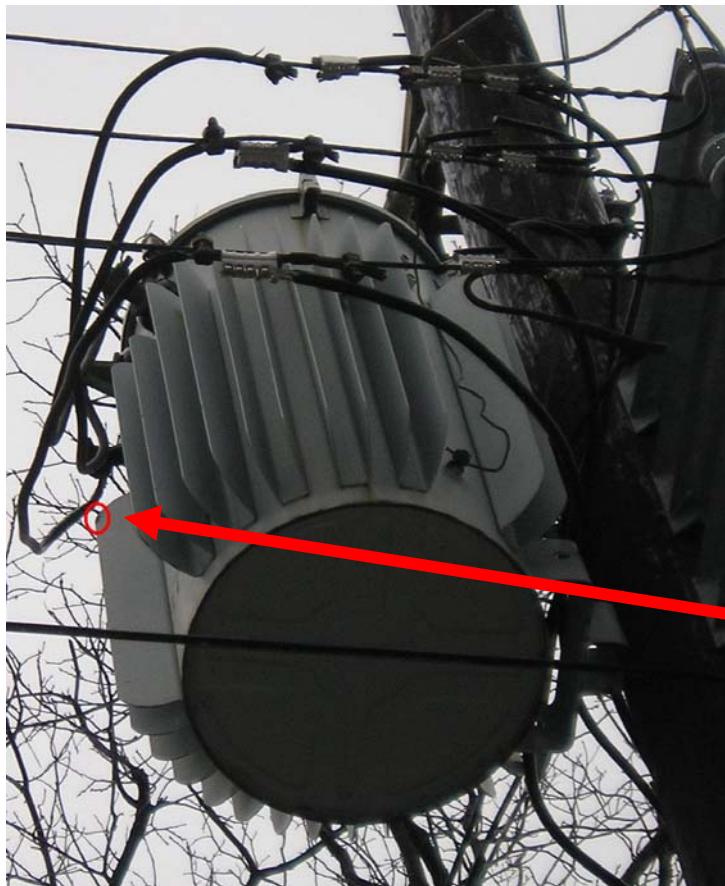
“This is a 37.5 KVA, 120/240v transformer with 2/0 copper conductor connecting it to the secondary bus. One conductor had rubbed against the cooling fin of the transformer and burned the conductor for about 10” back to the secondary bushing of the transformer. This leg was carrying no load at the time that it was checked.

Charred cooling fin of transformer
